SS Cyril and Methodius University, Skopje
INSTITUTE OF EARTHQUAKE ENGINEERING AND
ENGINEERING SEISMOLOGY, IZIIS

Historic buildings and monuments in North Macedonia: treatment and retrofitting aspects

***“Seismic assessment and retrofitting of masonry and preserved structures”
Athens, 13 September 2023***

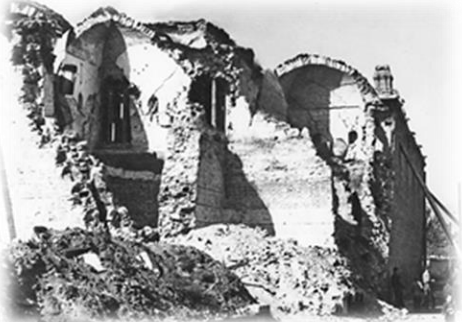
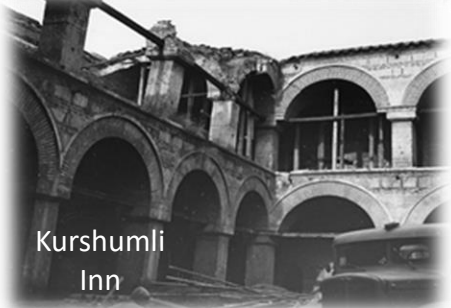
Mustafa Pasha mosque

- entire monument fund was more or less damaged
- failure of individual parts of the structures
- large cracks
- inclination and deformations of structural elements
- part of it was completely destroyed

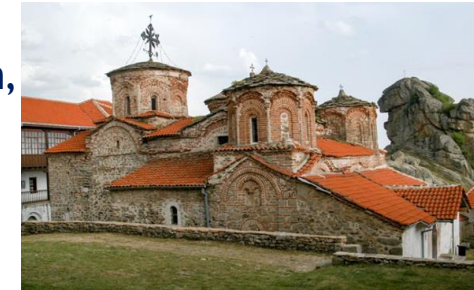
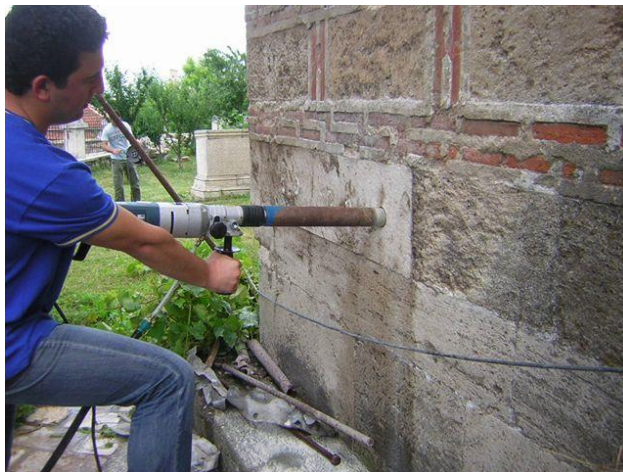
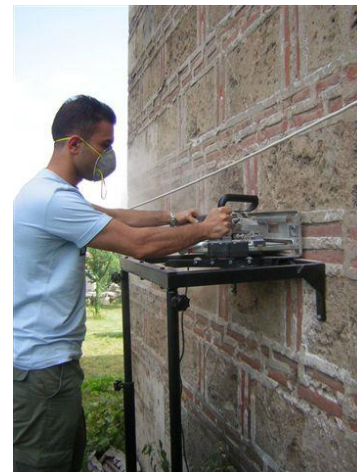
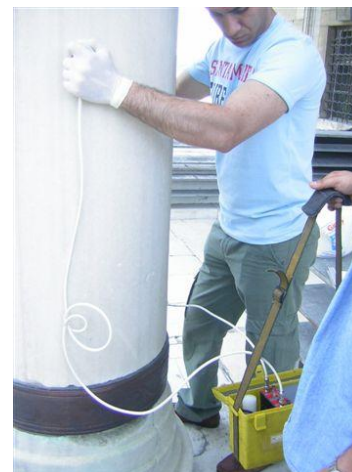
3. Structural identification

- ✓ in-situ technical measurements, investigation of the built-in materials, determination of dynamic characteristic through AVT

Modal Values
Frequency = 5.092 Hz
Damping = 0.983 %
Complexity = 1.809 %

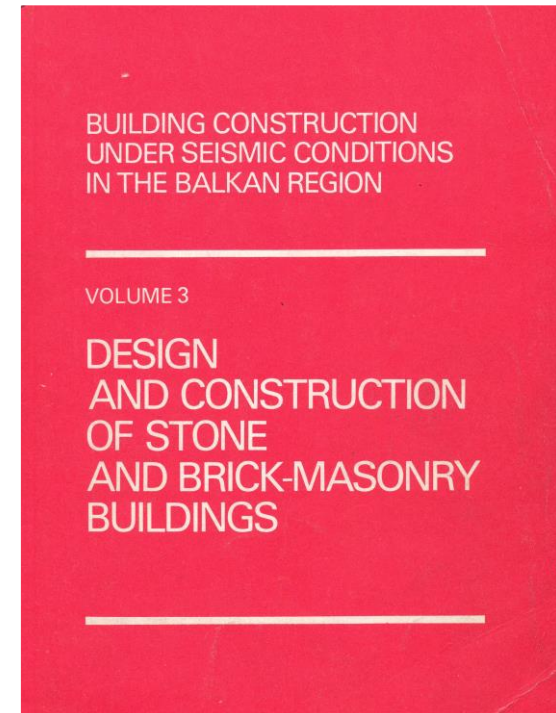
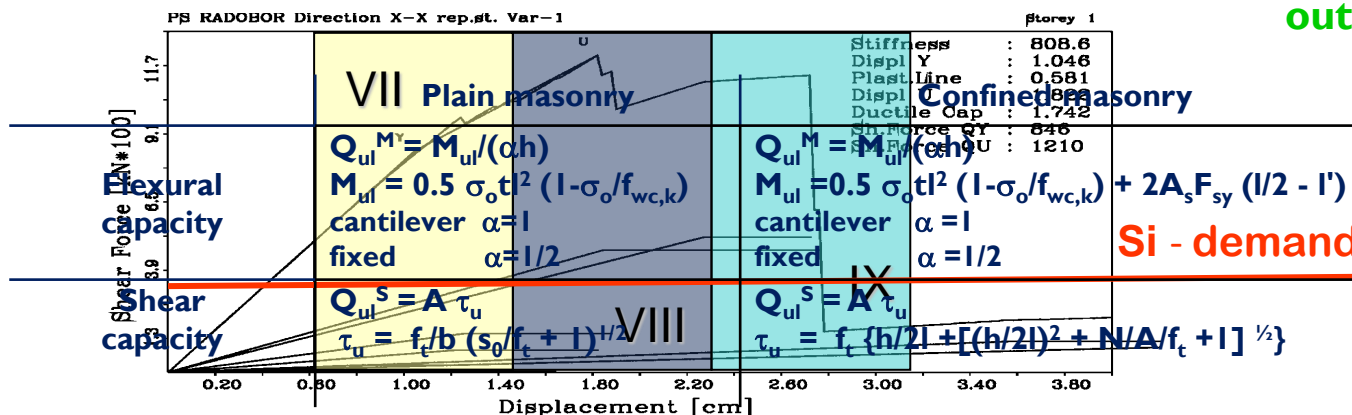
IZIIS' integrated approach: Bearing and deformation capacity of existing structure

Bearing Capacity (Q_{ul}) = ultimate storey transversal force Q_{ul} , which compared with the demanded equivalent seismic force S_i , gives the safety factor against failure, $F_u = Q_{ul}/S_i$

Deformation Capacity (μ) = storey ductility capacity as ratio between maximum story displacement and displacement at yield point, $\mu_{max} = d_{max}/d_y$

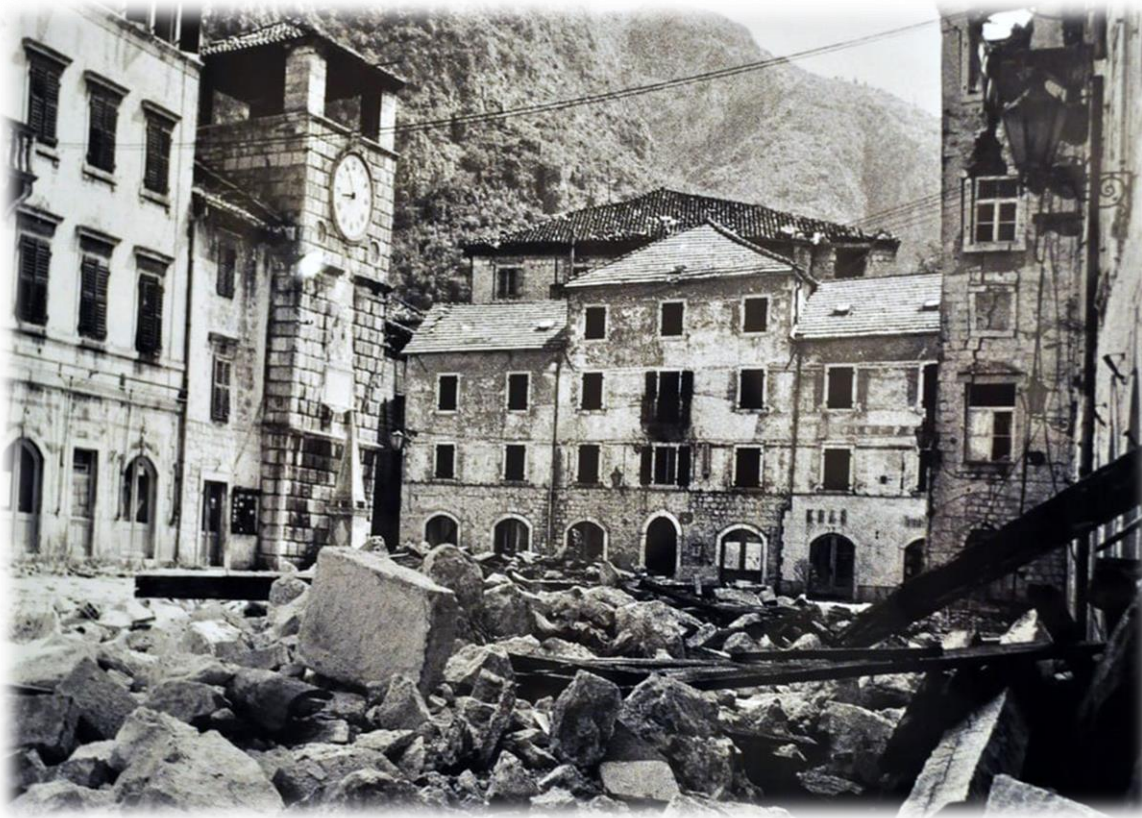
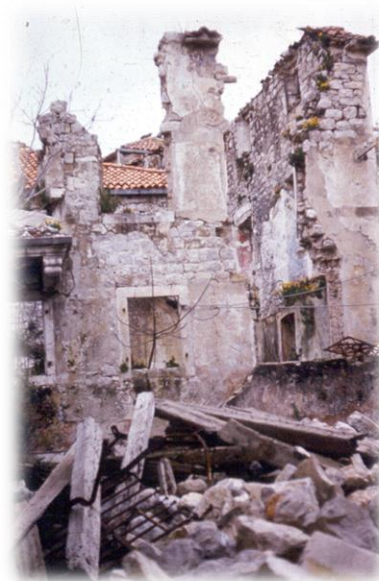
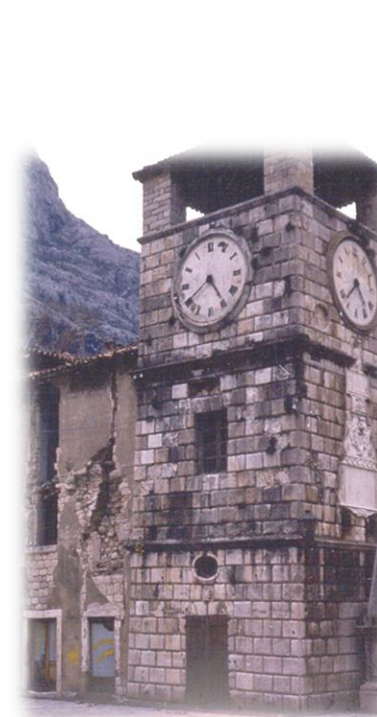
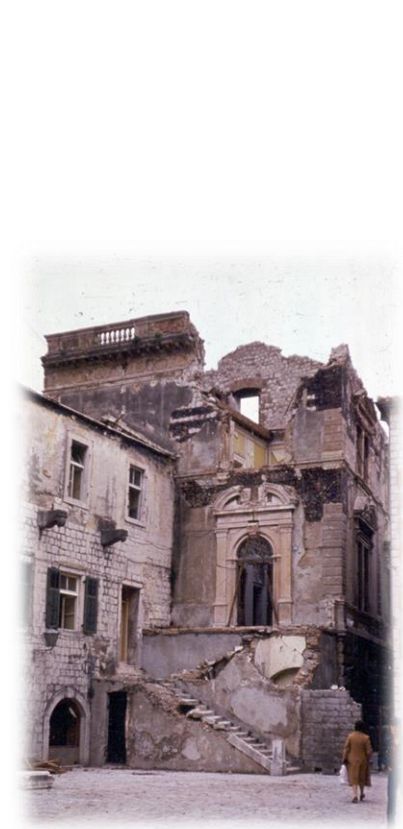
I. old towns along Mediterranean coast

- damages after 1979 Montenegro earthquake

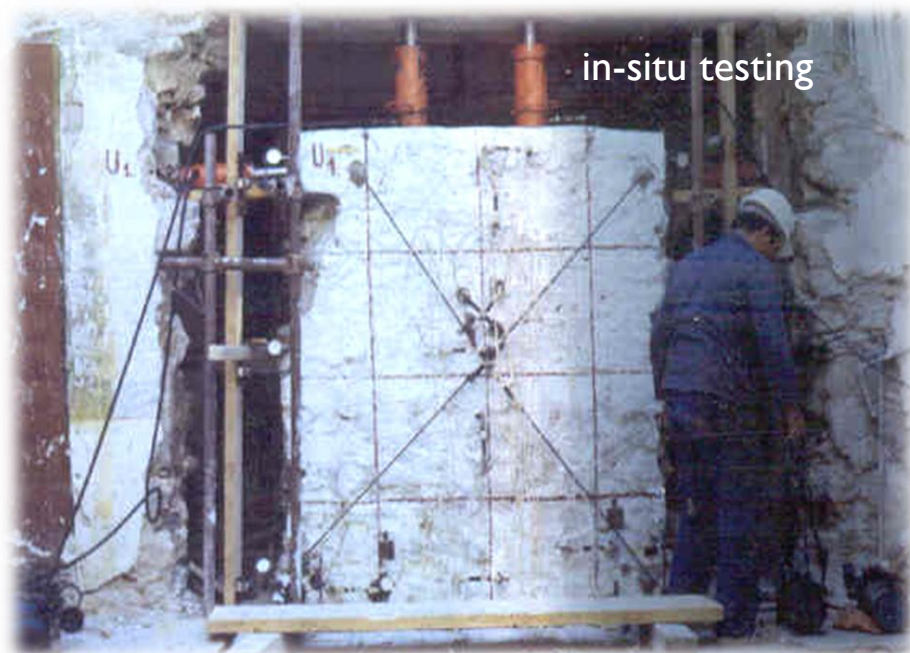
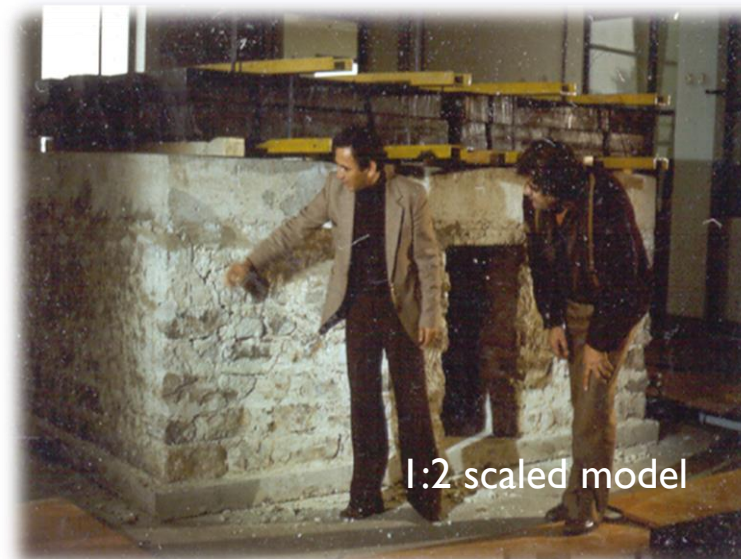
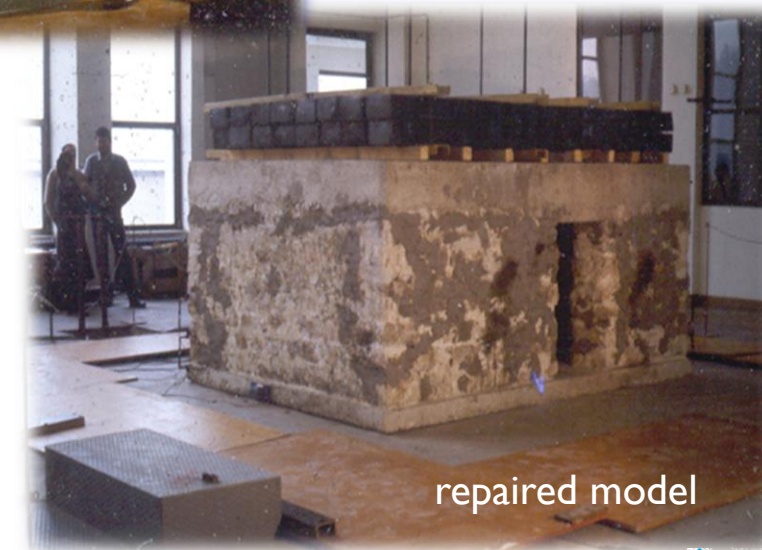
- extensive in-situ, experimental and analytical investigations for searching optimum conditions and methods for reconstruction, repair, strengthening of structures (1979-1984)

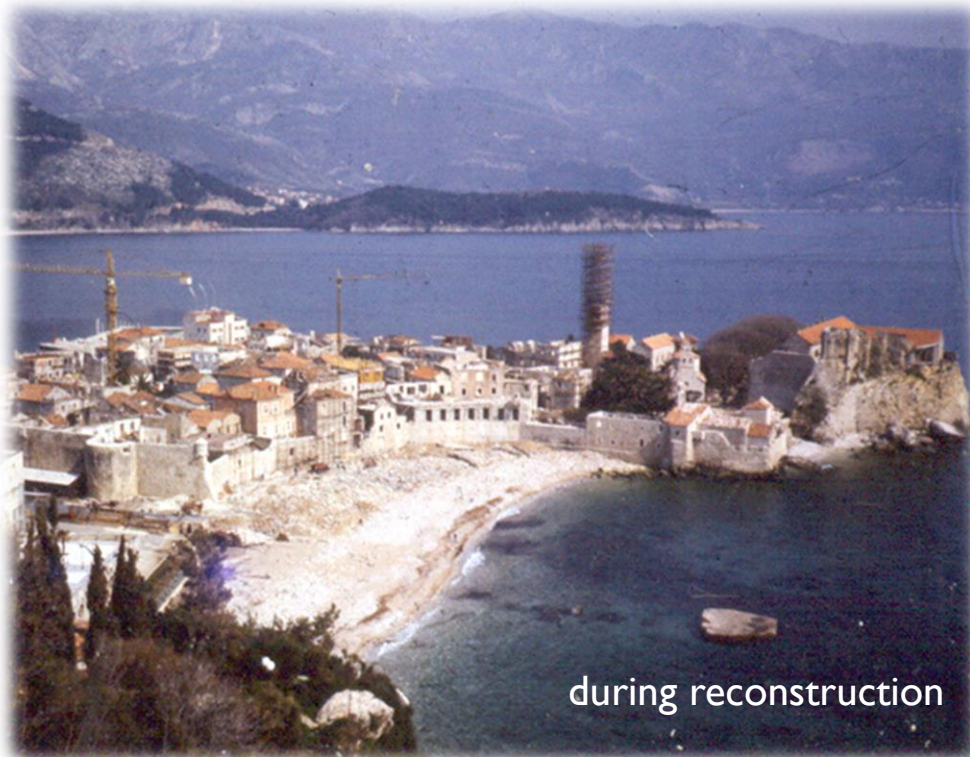
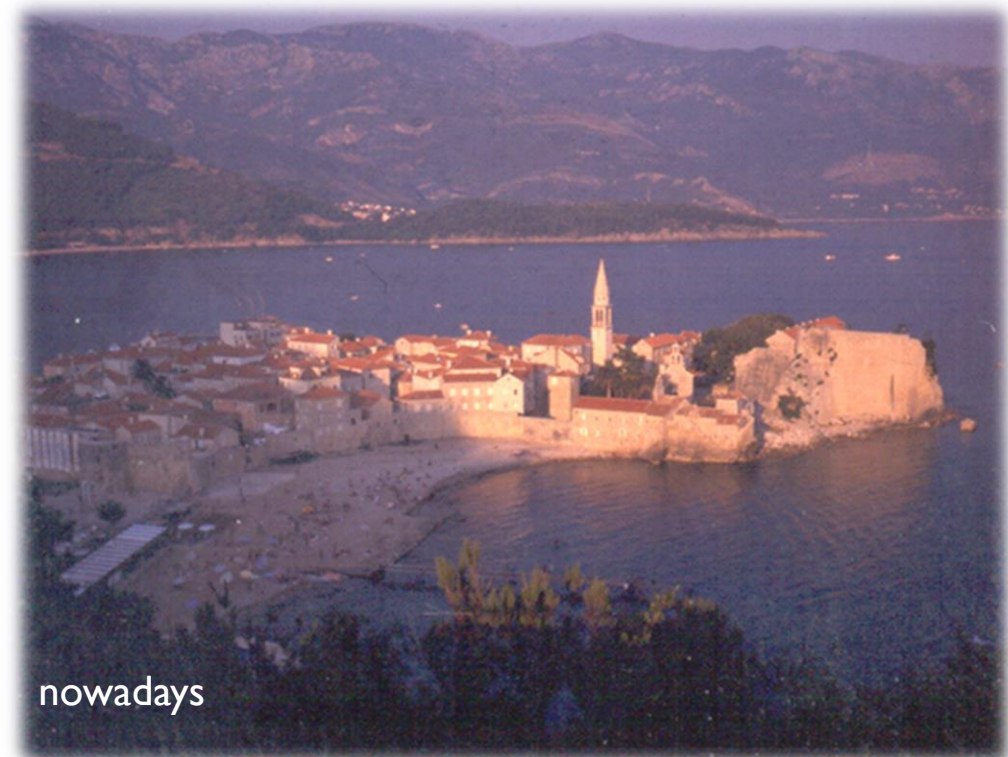
- repair and strengthening of more than 300 buildings in old town of Budva, applying acquired knowledge on application, material consumption and effect of injection

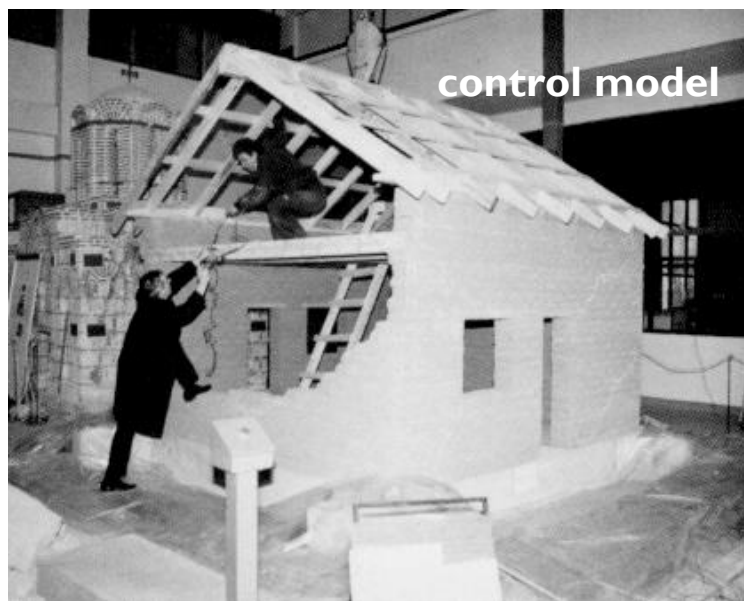
- 1996-1998: extension of GSAP - shaking table testing at IZIS of two 1:2 scaled models of a typical southwestern American *tapanco-style* building

- GSAP project ends with ...
... practical aspects for technologically feasible, minimally invasive and inexpensive techniques for stabilization of adobe buildings

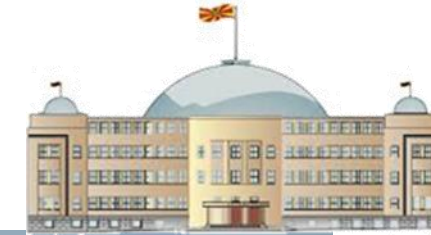
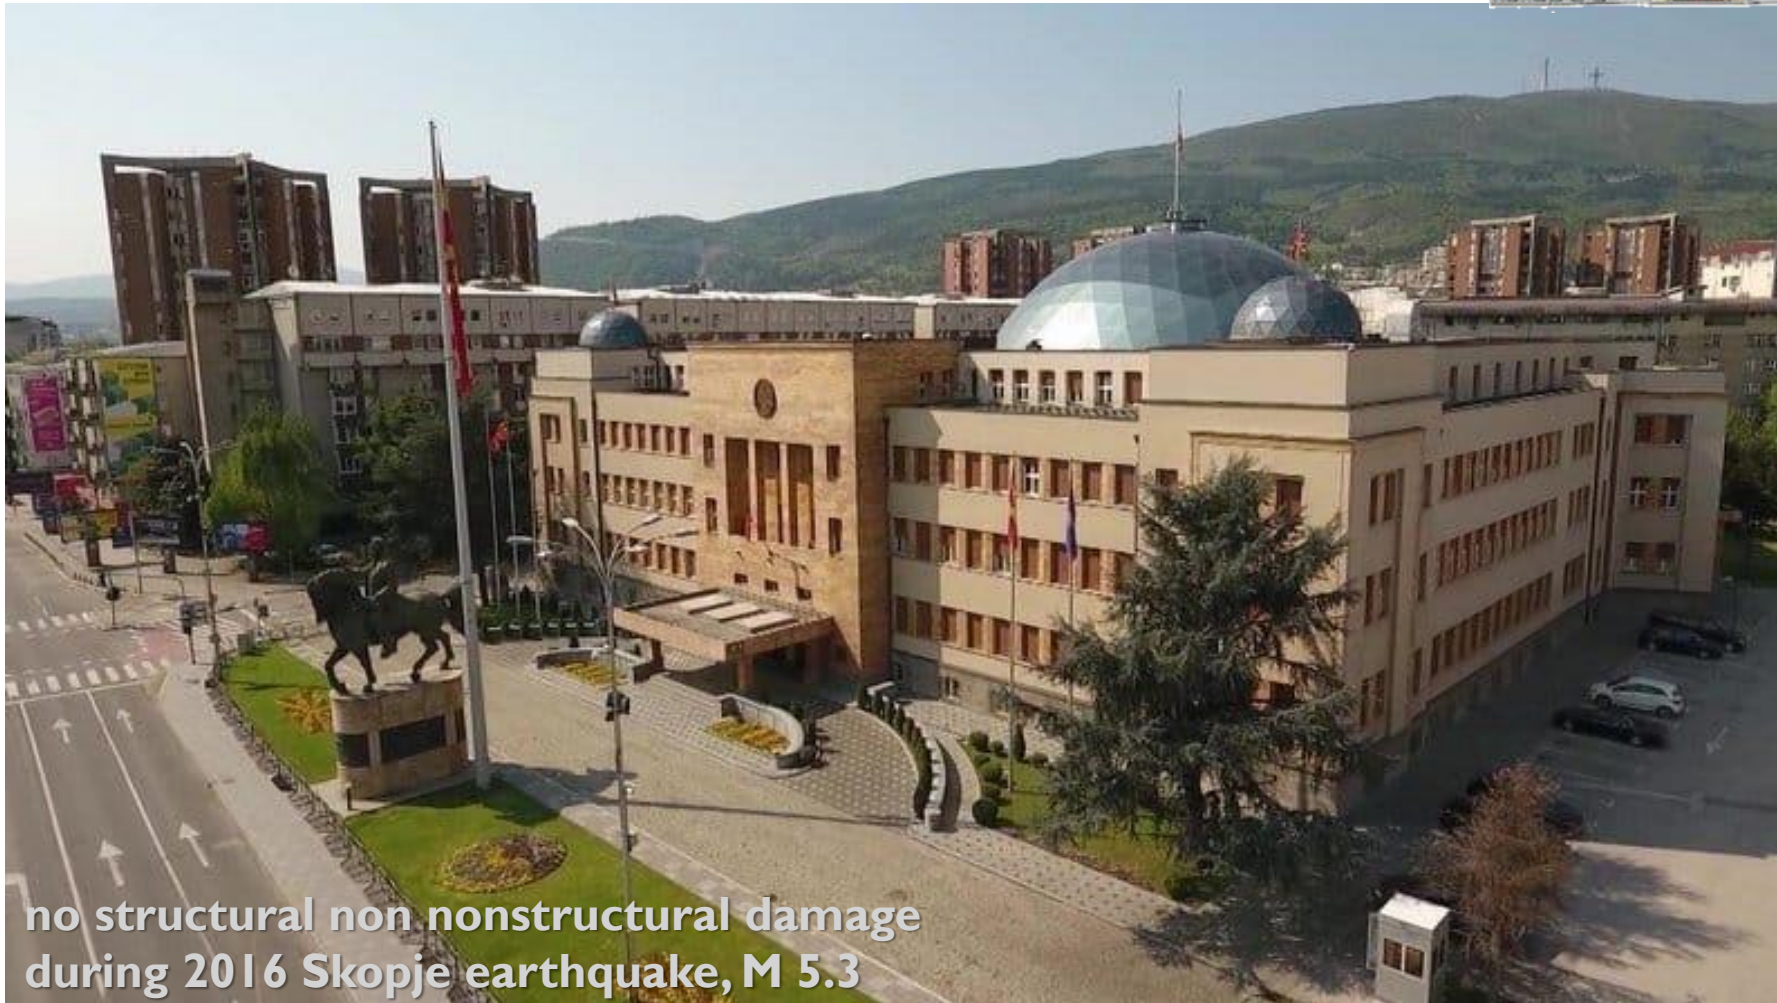
3. Parliament building in Skopje

- **2010-2013 - Strengthening while continuously functioning**

no structural non structural damage
during 2016 Skopje earthquake, M 5.3

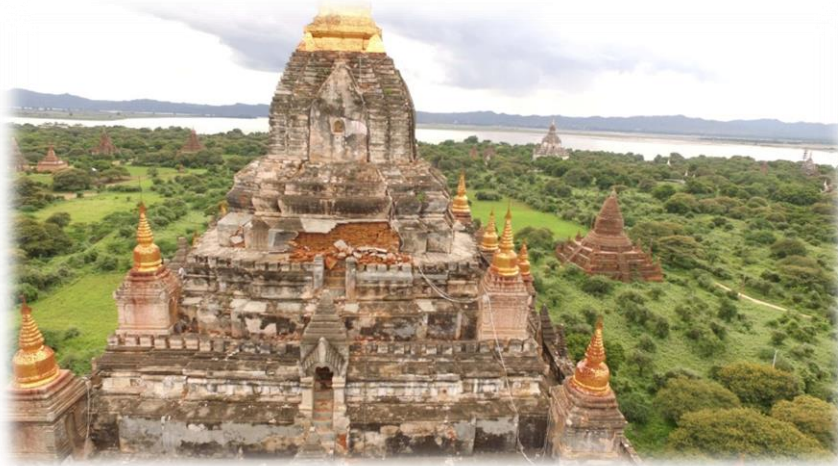
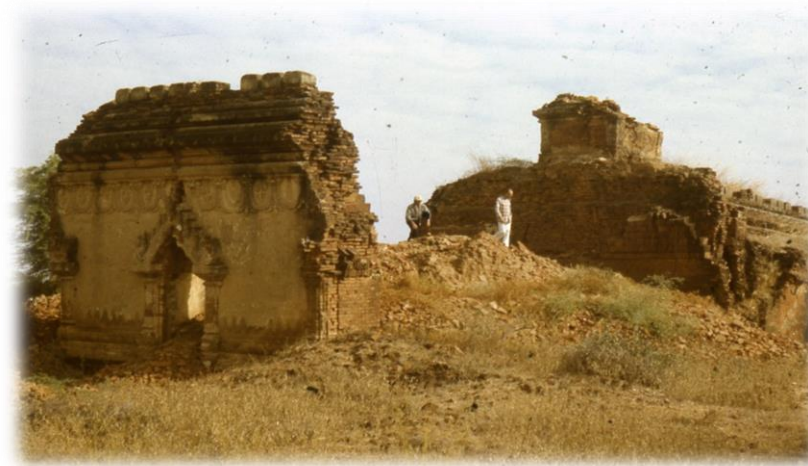
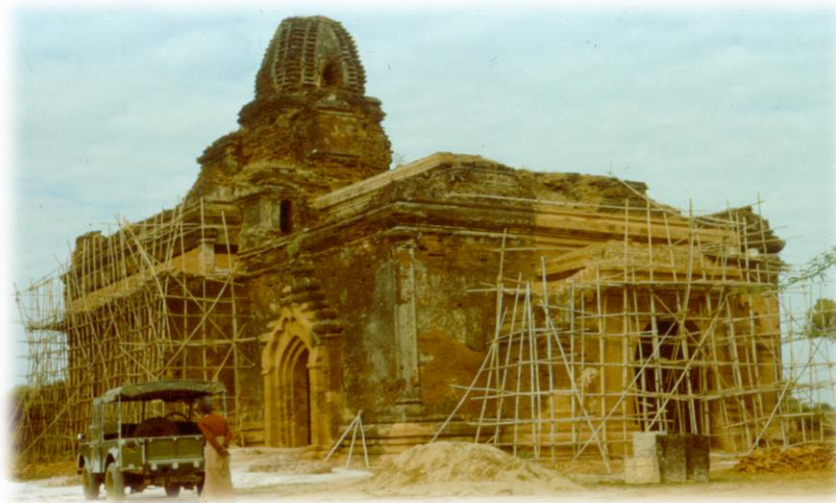
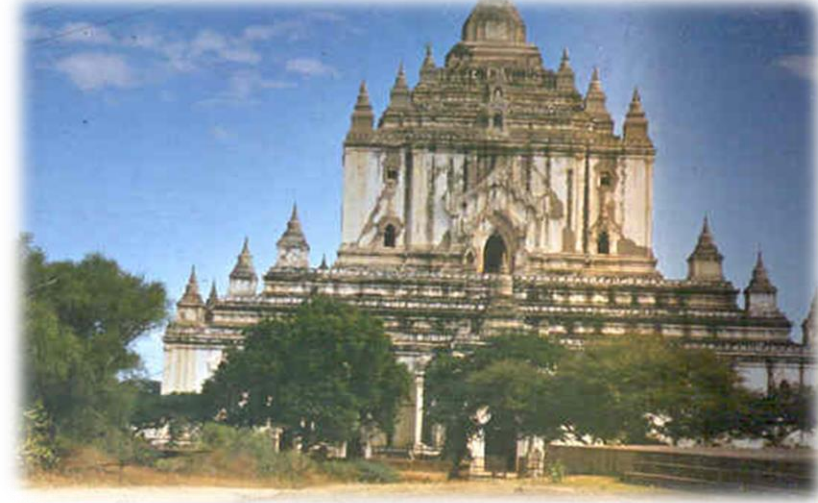
I. Monuments in Pagan - Burma (1978-1980)

- damages after 1975 Pagan earthquake

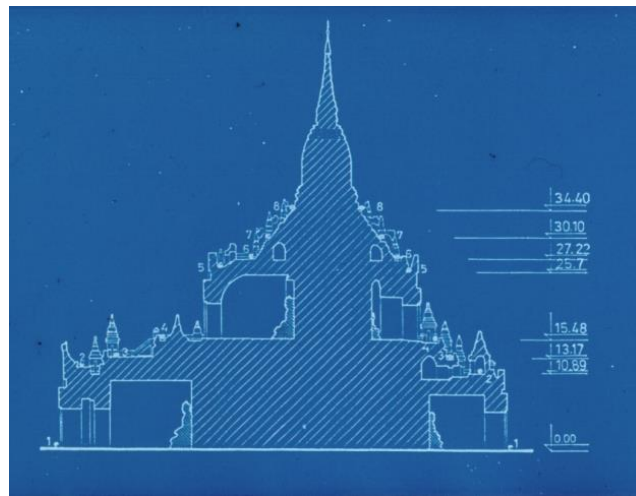
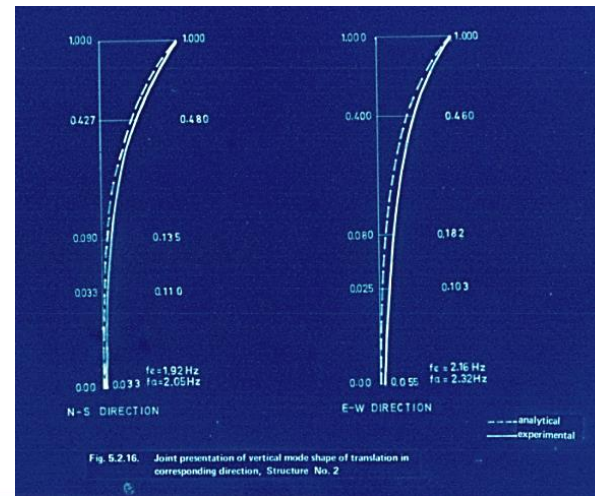
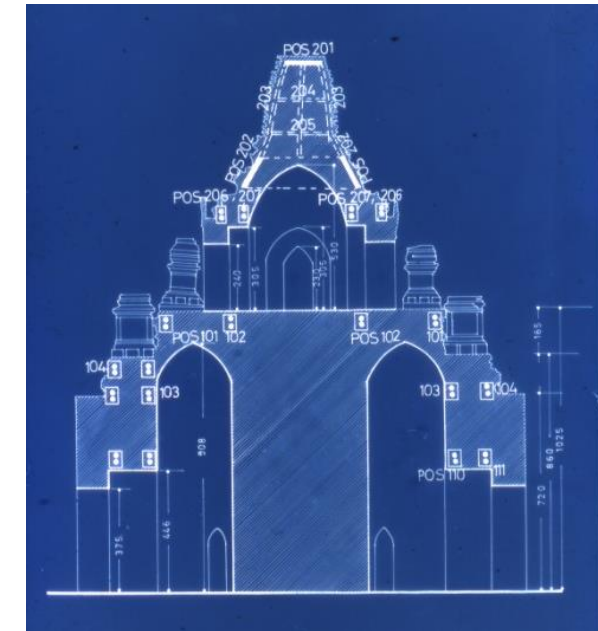
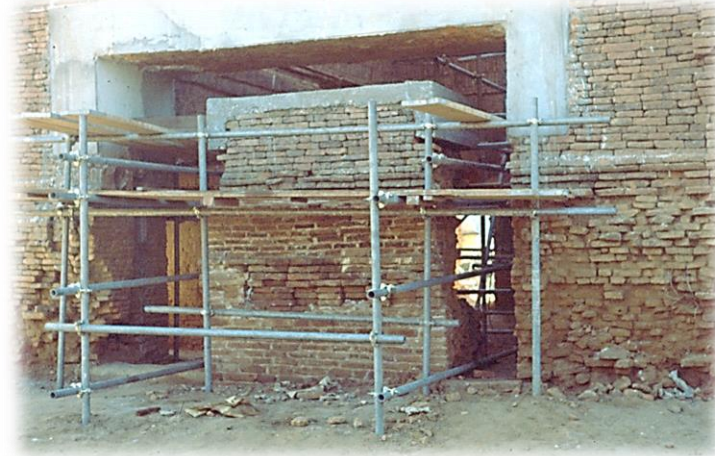
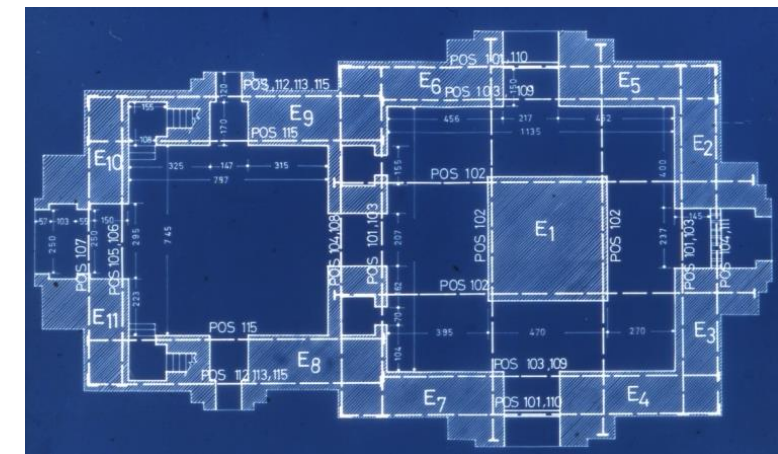
Developing and implementation of a methodology for repair and strengthening of pagodas & temples by injection and inserting of steel bracing or RC belts

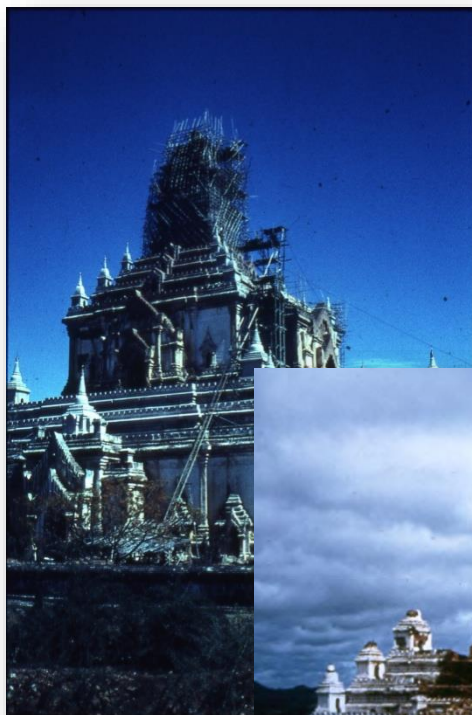
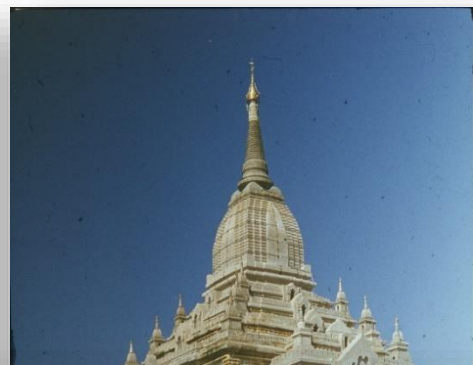
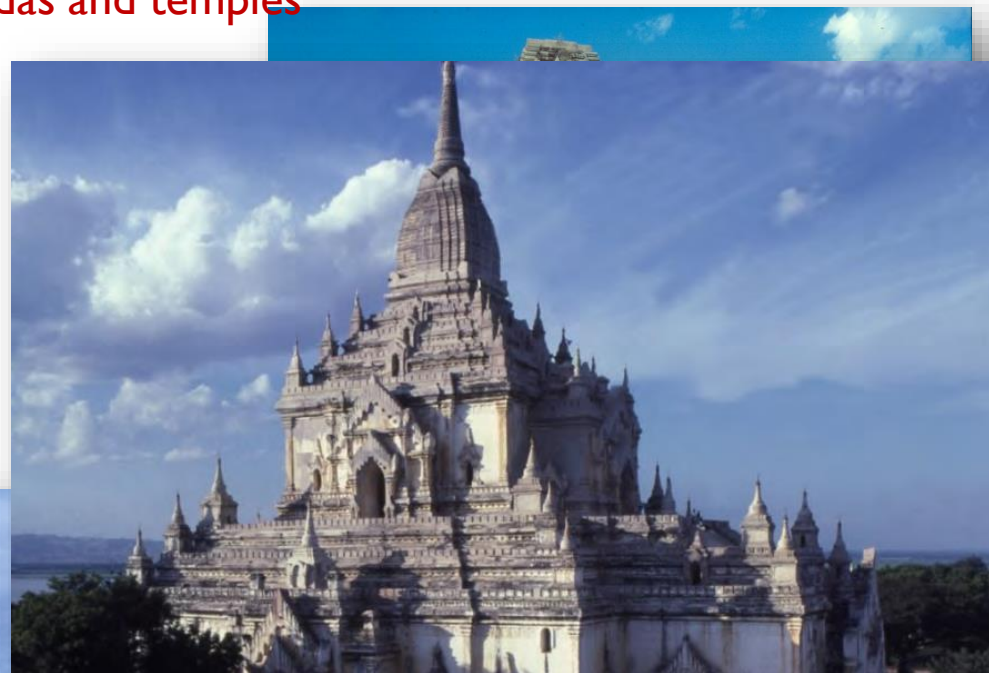
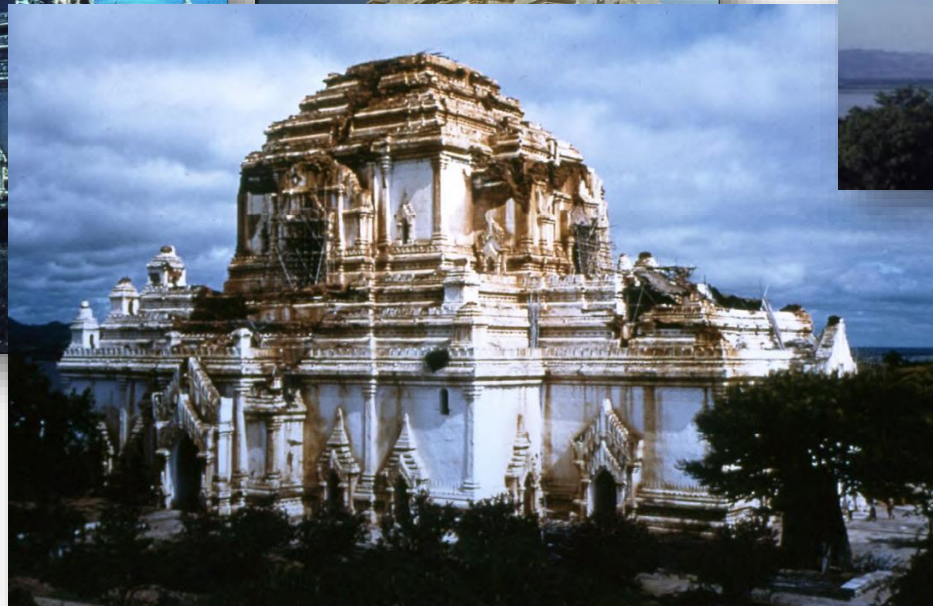
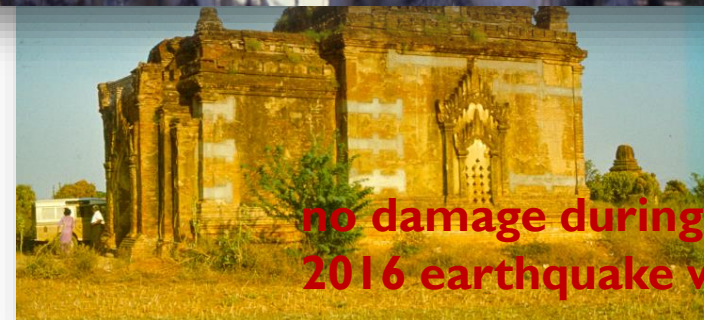
UNSECO/UNDP 78/023: implementation in 15 pagodas and temples

no damage during
2016 earthquake with M 6.8

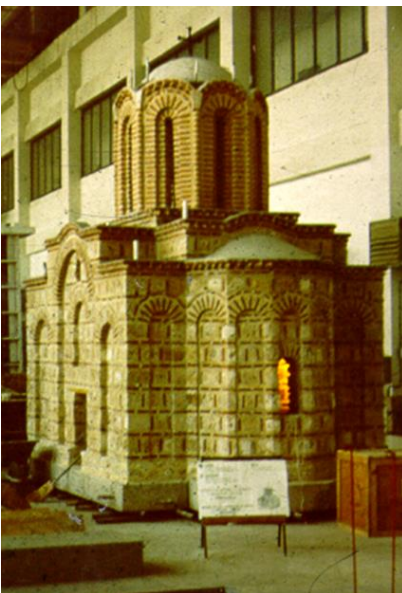
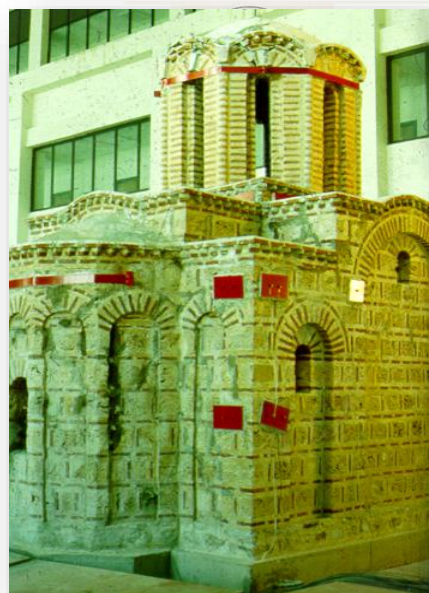
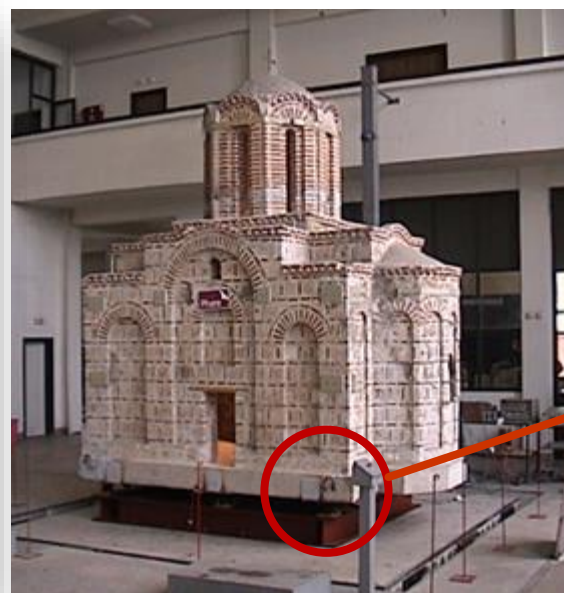
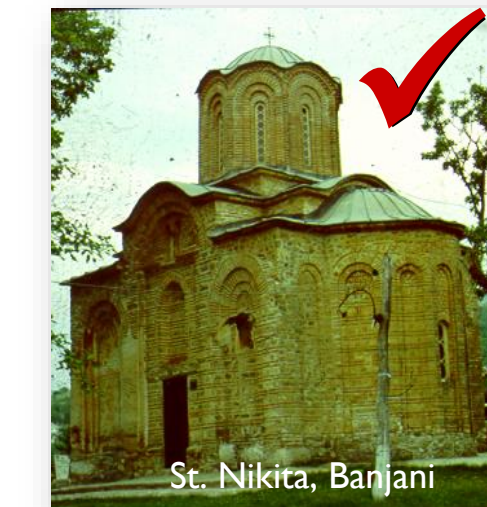
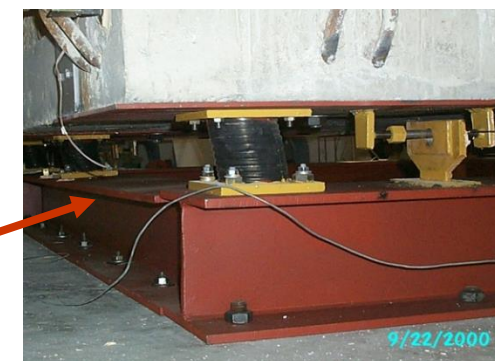
- Original - existing state
- Strengthened by ties and injection
- Base isolated

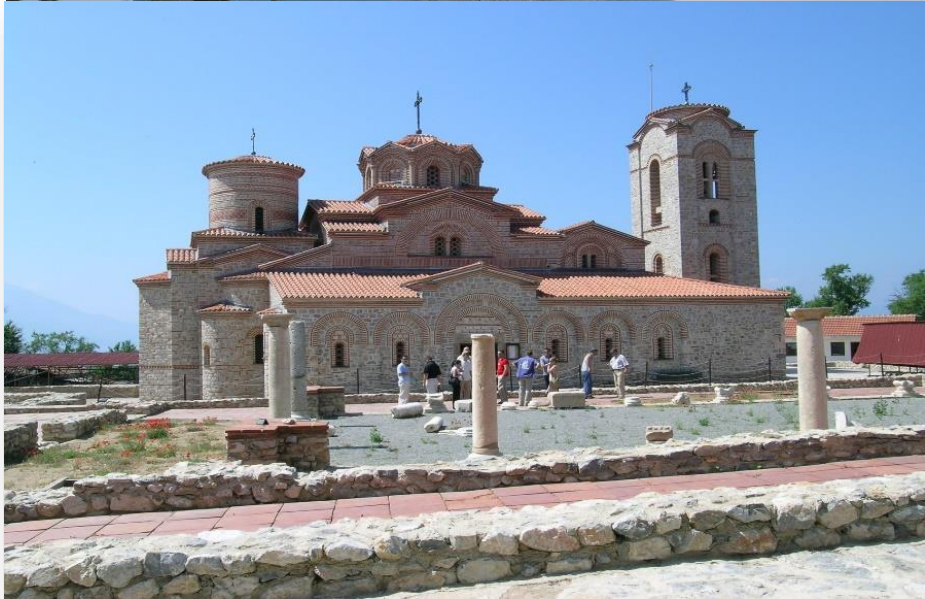
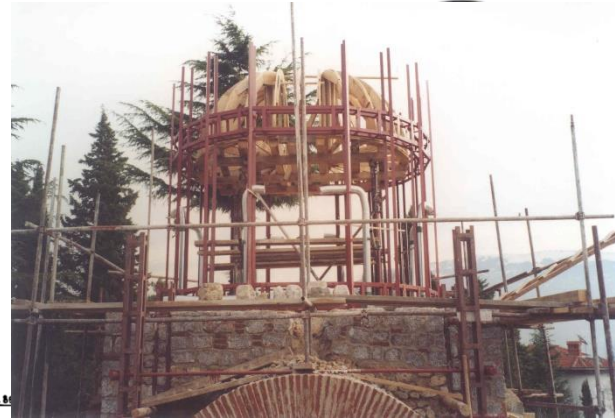
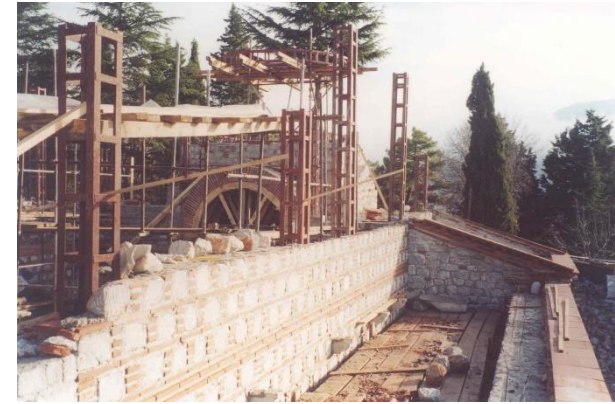
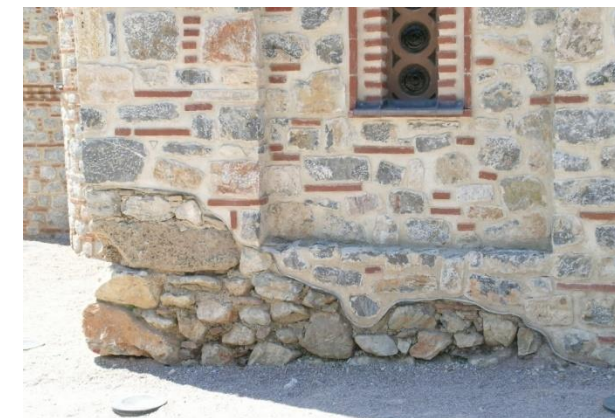
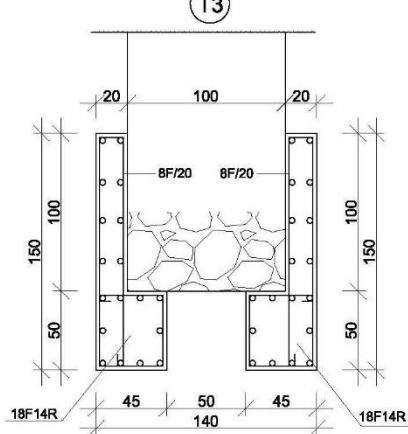
St. Pantelymon Church, Ohrid, (2001)

foundation

horizontal & vertical steel ties

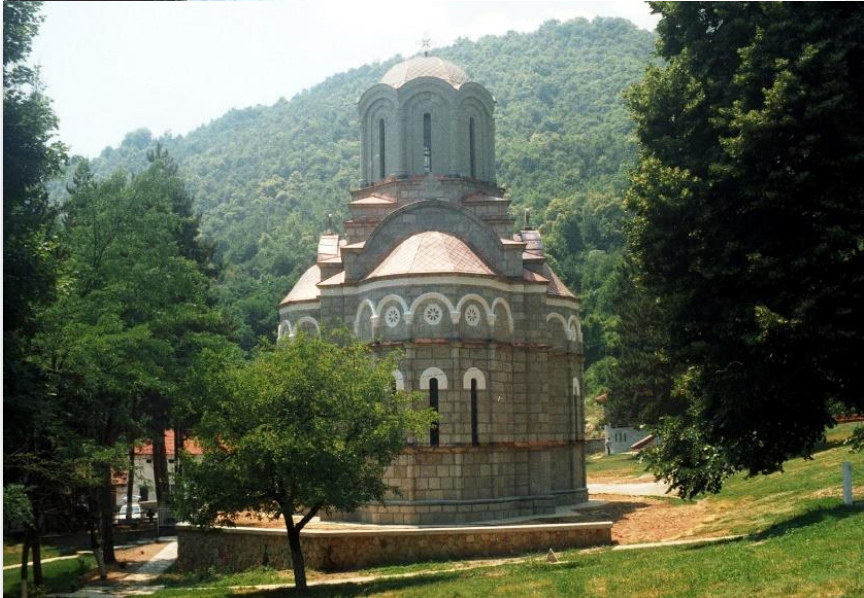
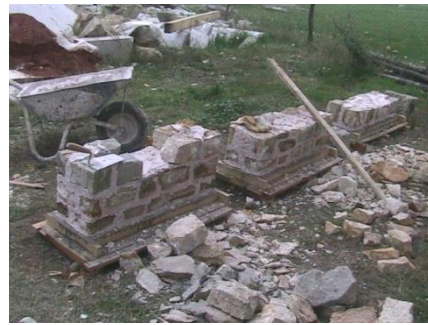
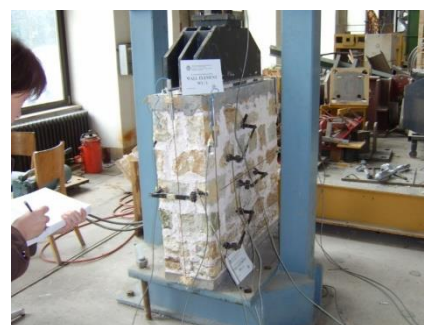
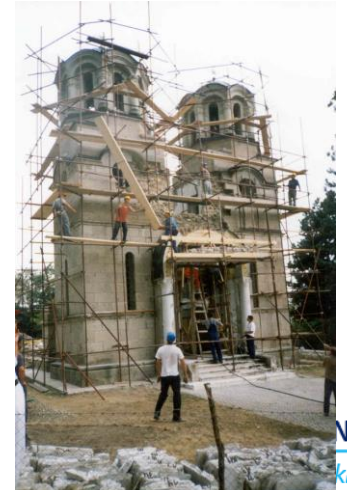
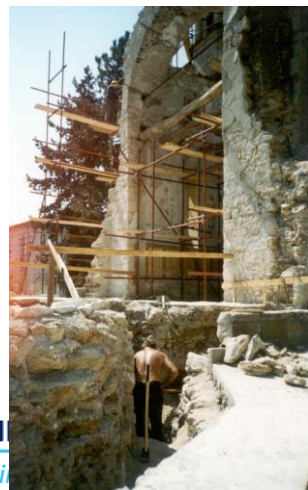
St. Athanasius Church, Leshok (2007)

3. implementation in reconstruction of churches

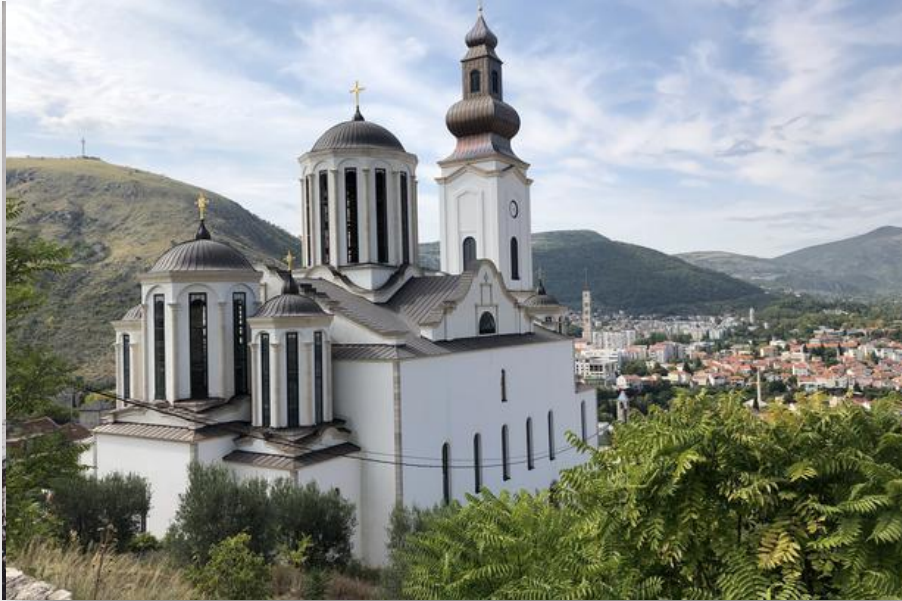
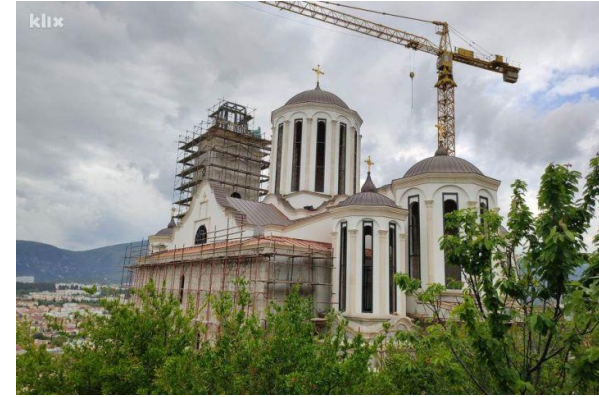
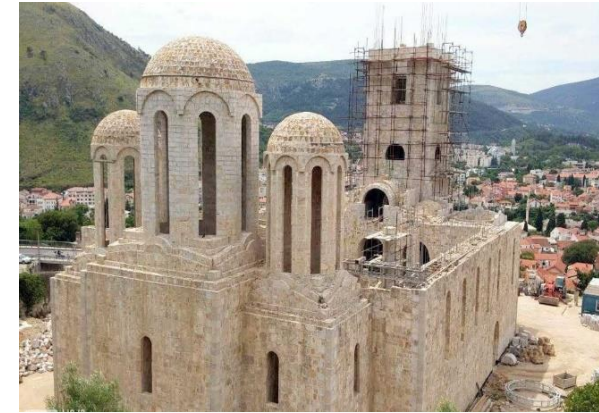
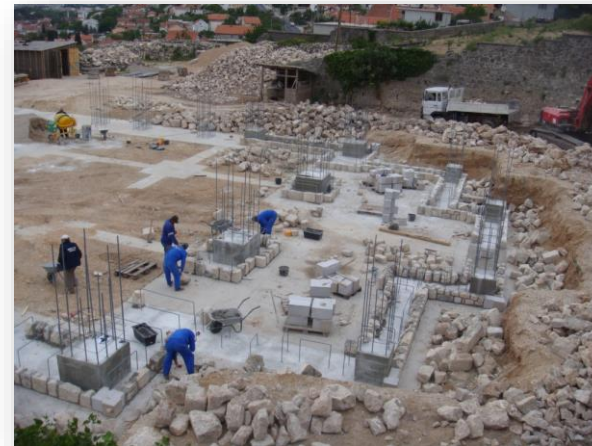
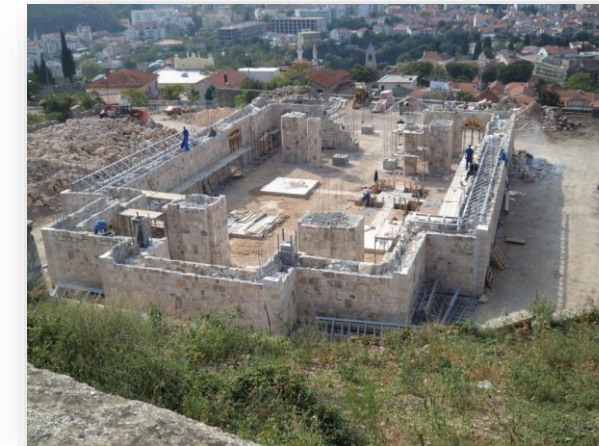
Church of Holy Trinity, Mostar (2011)

3. implementation in reconstruction of churches

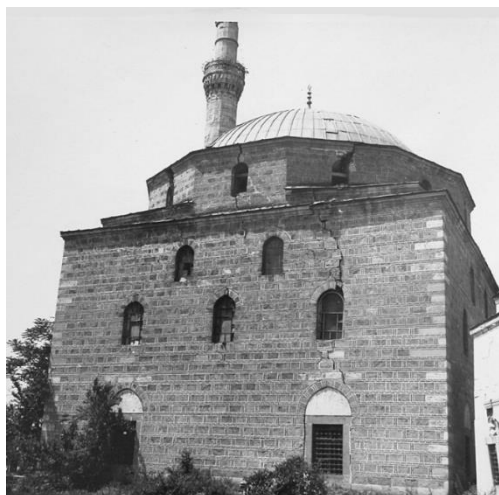
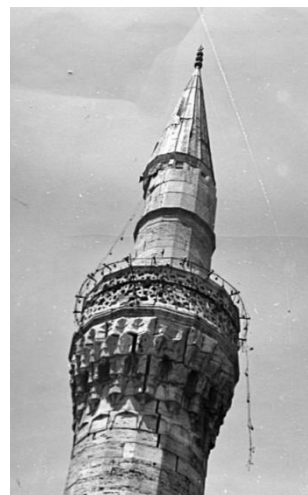
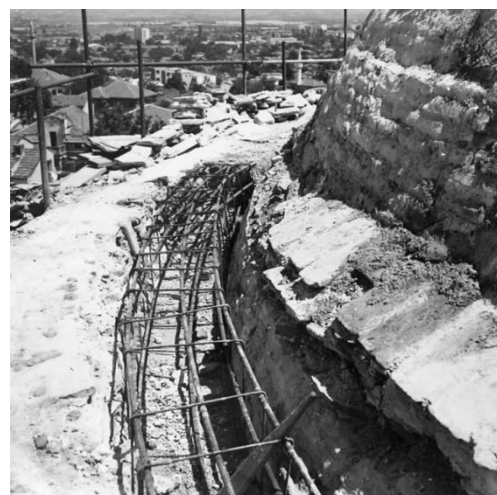
Seismic Retrofitting of Mustapha Pasha Mosque in Skopje, (2008-2010)

- one of the biggest and best-preserved Ottoman monuments in Skopje and Balkans
- damaged by Skopje earthquake in 1963 (domes, east facade, minaret)
- today monument of extraordinary importance

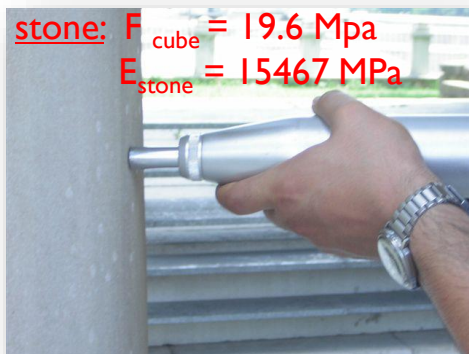
in-situ investigation

stone: $F_{cube} = 19.6 \text{ Mpa}$
 $E_{stone} = 15467 \text{ MPa}$

$f_{1-1}=3.0\text{Hz}$ $f_{2-2}=3.2\text{Hz}$ $f_m=1.04\text{Hz}$

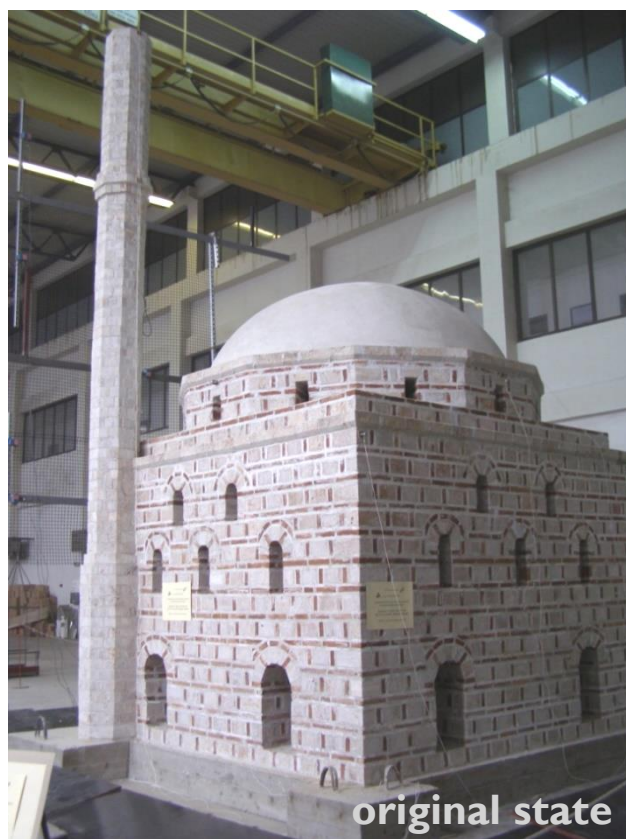
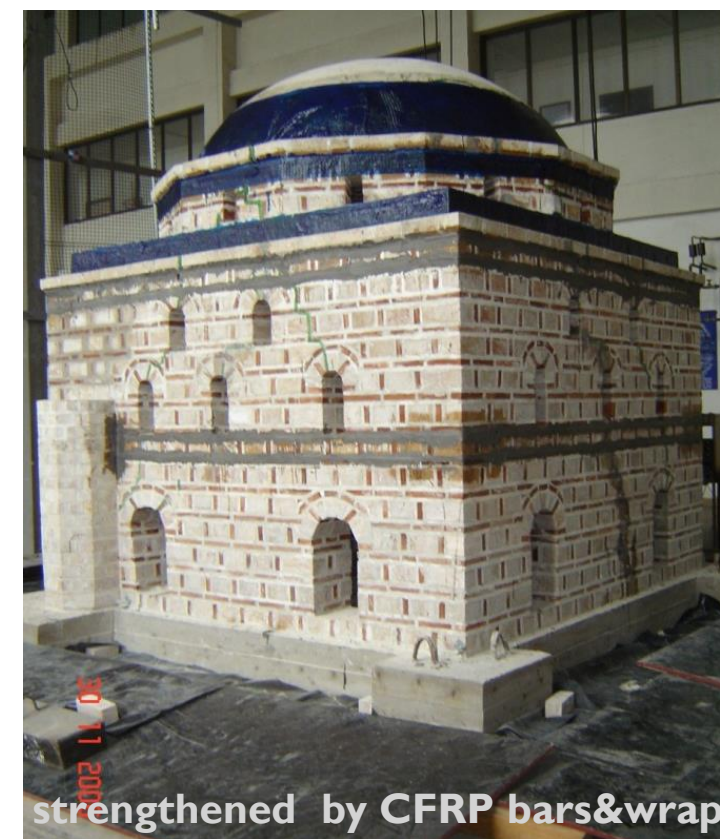
Shaking table testing of 1:6 scaled mosque model
