National Technical University of Athens
School of Mining and Metallurgical Engineering
Laboratory of Engineering Geology and Hydrogeology

Land subsidence phenomena at the wide area of Thessaloniki detected by using radar interferometry techniques

Loupasakis C.¹, Raspini F.², Rozos D.¹ & Moretti S.²

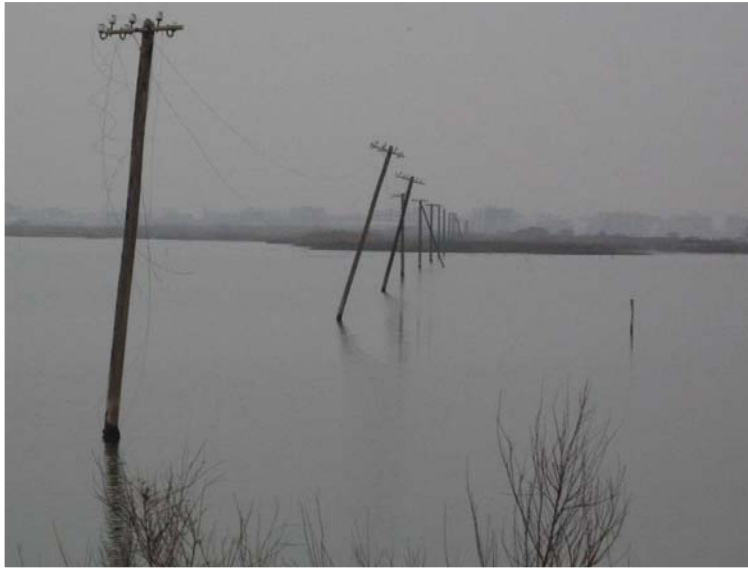
Submerged remnants of the old electricity network. Those poles were installed along the side of a road constructed in the SW of Kalochori in 1975. The photo was taken in 2008.

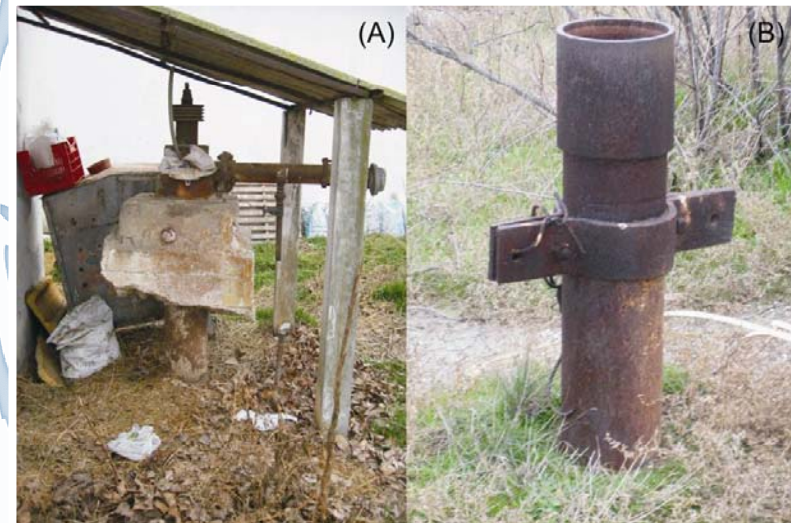
Emerged well pipes due to the subsidence phenomenon. (A) 100 m deep well located in the Institute of Wheat Cultivation (SW of Kalochori). The pipes have been extracted 0.9 m above the ground surface. (B) Well located near the Paleomana pumping station (SW of Kalochori). The pipes have been extracted 0.35 m above the ground surface. The photos were taken in 2008.

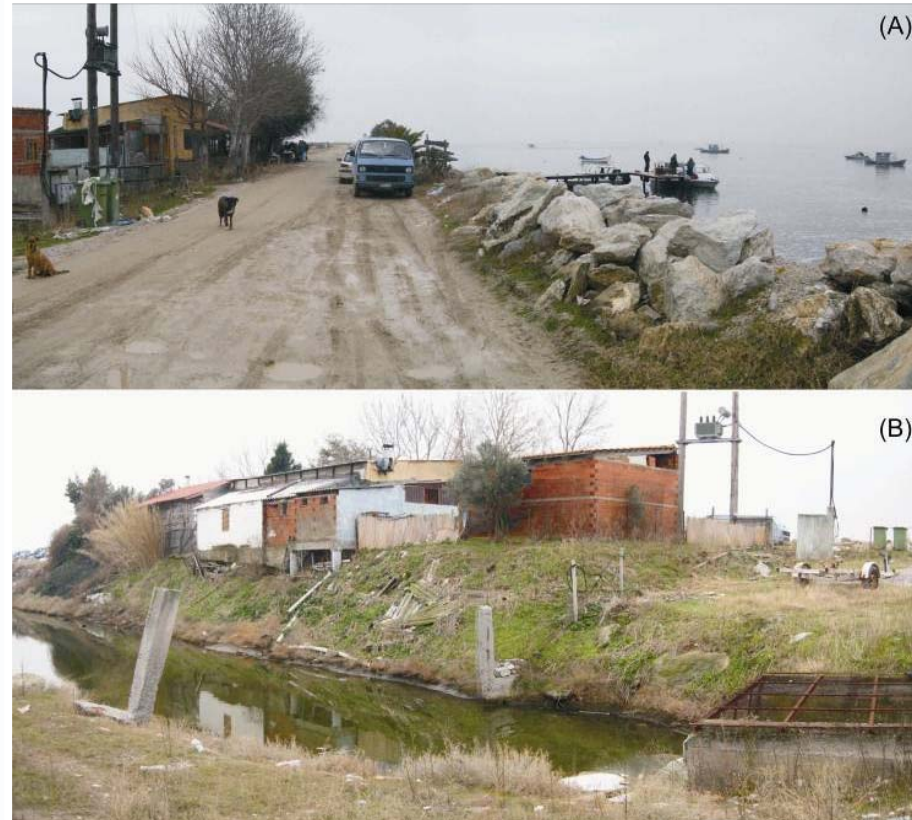
Views of the main embankment constructed at the South of Kalochoiri. (A) Front view of the embankment. The sea level is about 1m below the road level. Boulders have been installed as breakwater structures. (B) Back view of the embankment in the same location (note the transformer on the top of the wooden pillars). The lagoon water level is 4 to 5m below the road level. Comparing the pictures it becomes obvious that the inland is at least 4m below the sea level.

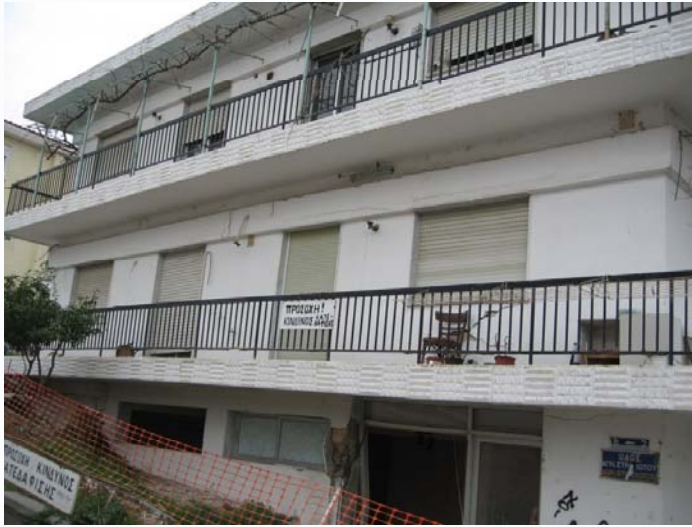
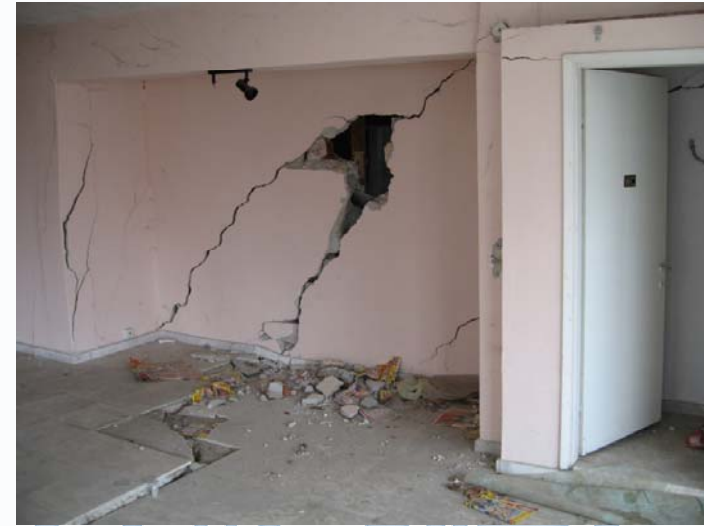
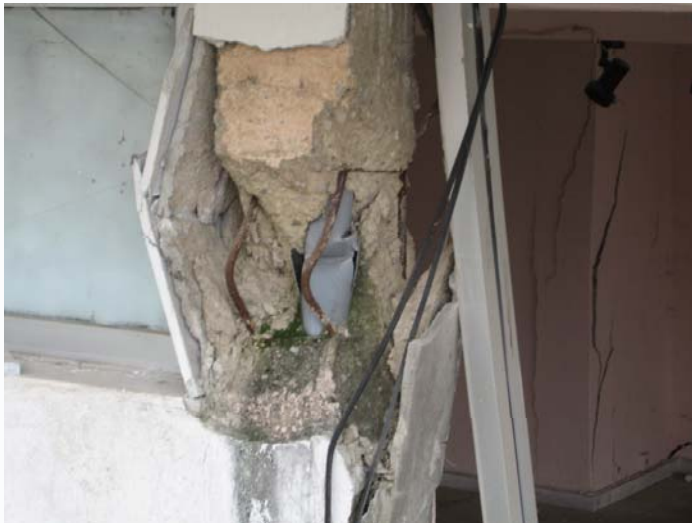
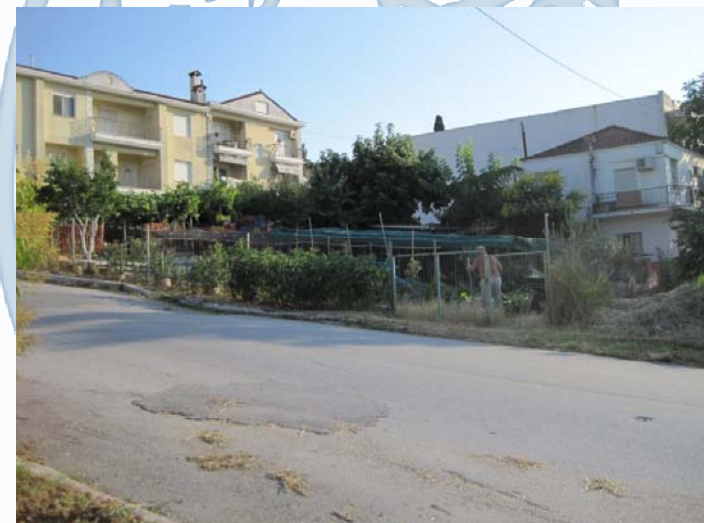
- Anthemountas basin is located on the eastern side of Thessaloniki, named after the homonymous river. It extends with a NW-SE orientation from the Thermaikos gulf to the centre of the Chalkidiki peninsula
- This area draw the attention of the geo-scientists in 2005 when a series of fractures, causing damages to both buildings and roads, occurred at the Perea village, on the southern section of the basin's coastal zone.
- From the beginning these fractures were attributed to the overexploitation of the aquifers, although they manifested along the active Anthemountas Fault.

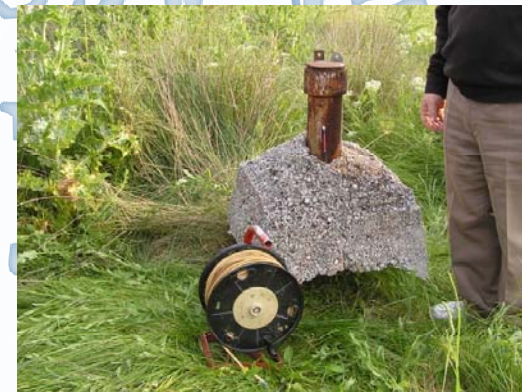
- In 2005 a series of fractures damaged at the upper Perea village.
- In short distance three public wells and an unknown number of private wells were operating.
- So, the operating wells with a 2,2m mean annual drawdown rate generated an extra drawdown and inside the limits of the intersecting depression cones of the wells the ruptures occur.

Well-casing protrusion has also been reported northern to surface ruptures, at the same time period.

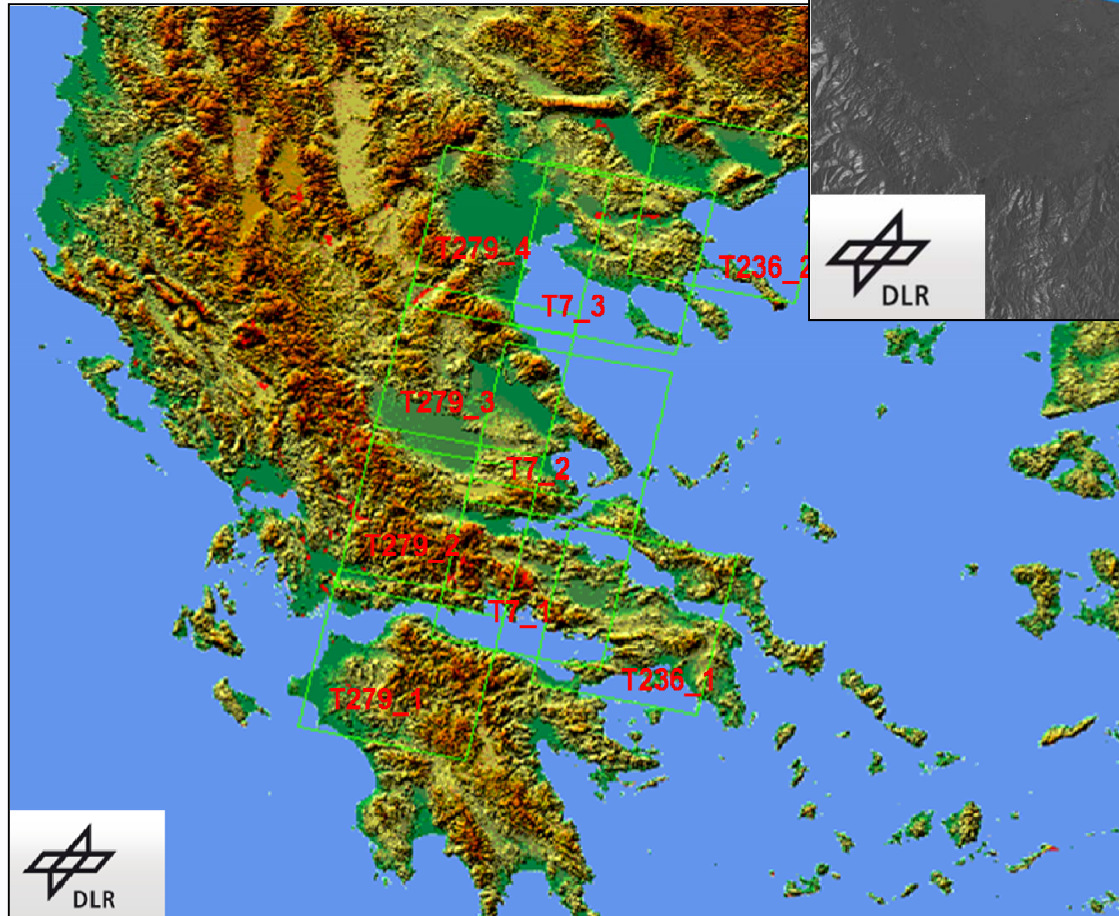
Evaluated PSI data

Displacement time-series on single radar benchmarks (precision ~ up to 1-3 mm on single measure)

Wide area product (WAP) PSI mapping provided by the German Space Agency (DLR)

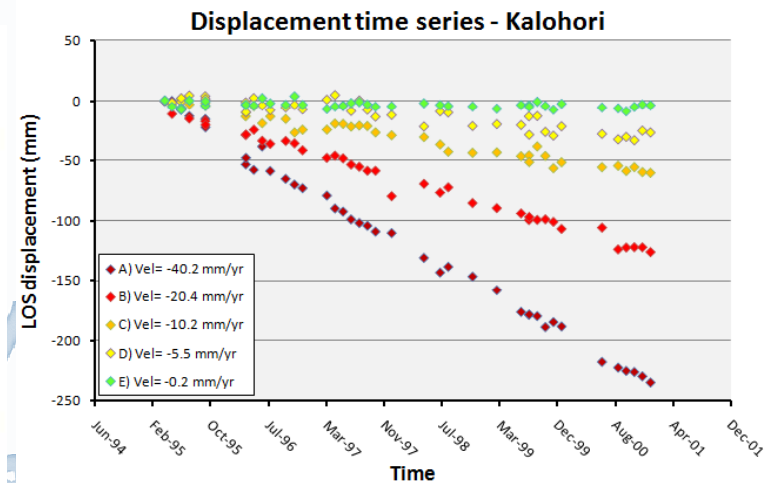
LOS displacement time series and yearly velocities of PS A, B, C, D and E

Land subsidence can be clearly identified in the coastal area of Kalochori. The highest LOS velocities range between 15 and 25 mm/yr in 1992-2003, with peaks of 40 mm/yr recorded in the SW of the village.

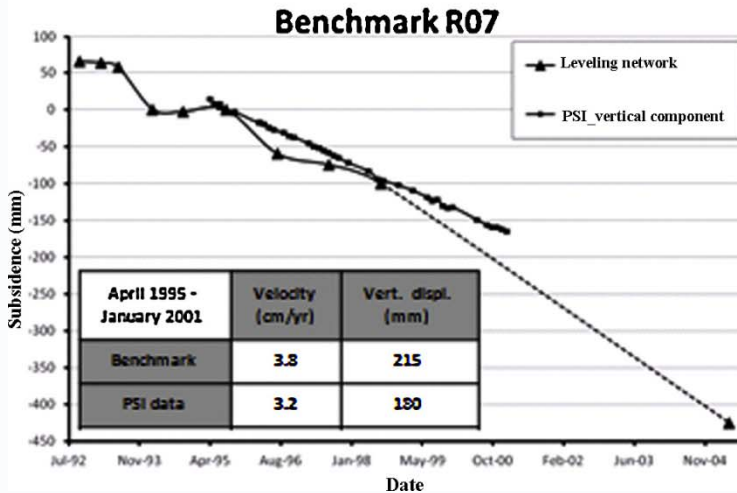
Comparison between the vertical component of PSI measures and leveling data at benchmark R20, R28, R07 and R02.

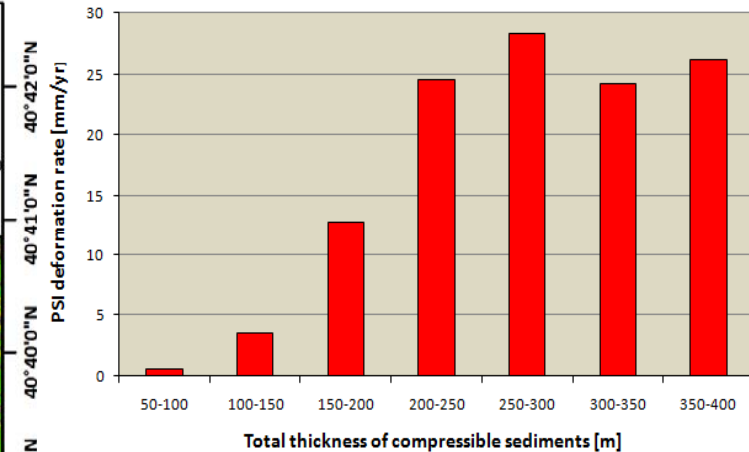
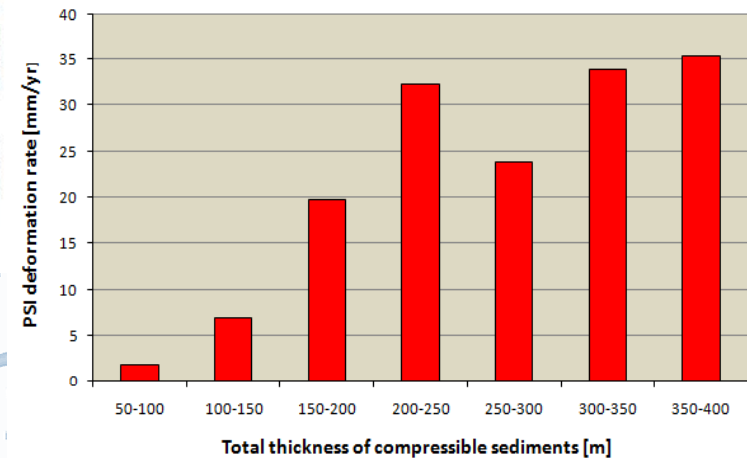
For both investigated areas (Sindos and Kalochori) it is observed that the thicker the cumulate compressible deposits the higher the estimated subsidence rates.

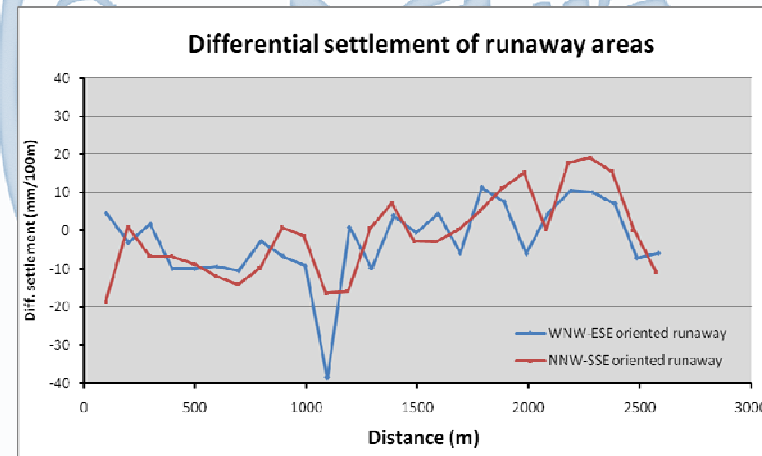
➤ In the airport area, observed LOS subsidence rates are 5–15mm/yr, with several points exceeding 20 mm/yr along the NNW-SSE oriented runway area.

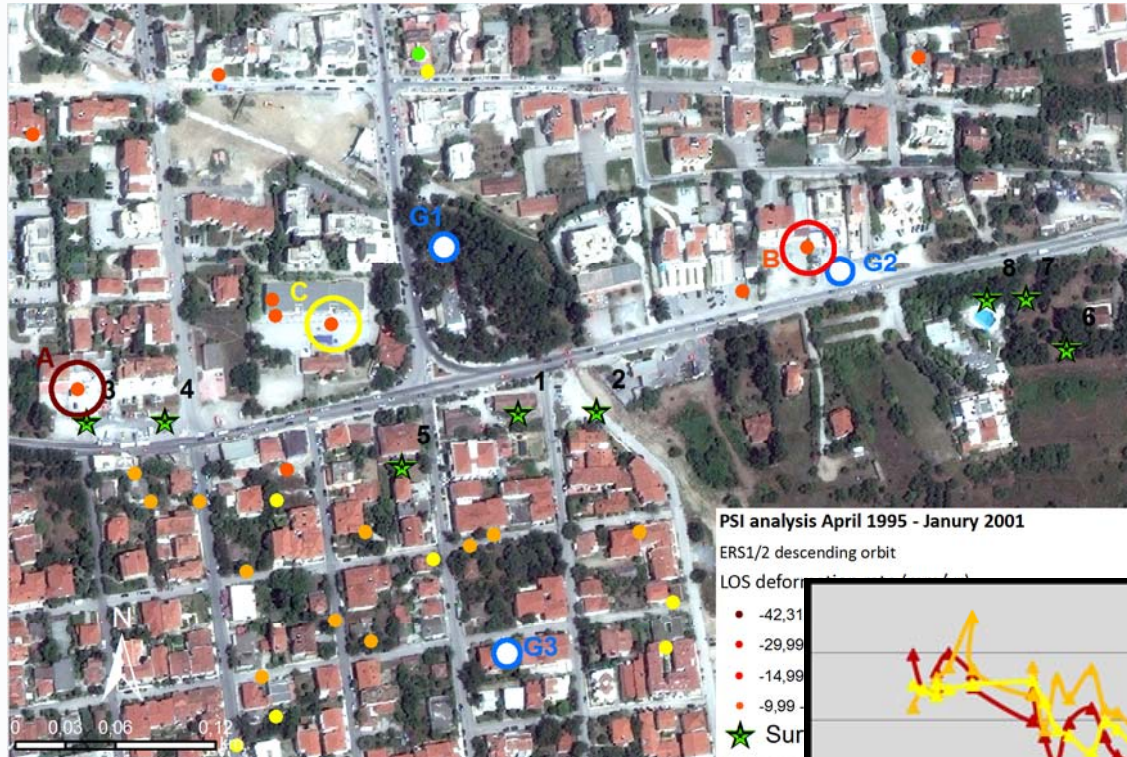
Close-up of PSI data for Perea village. Green stars indicate surveyed points A, B and C.

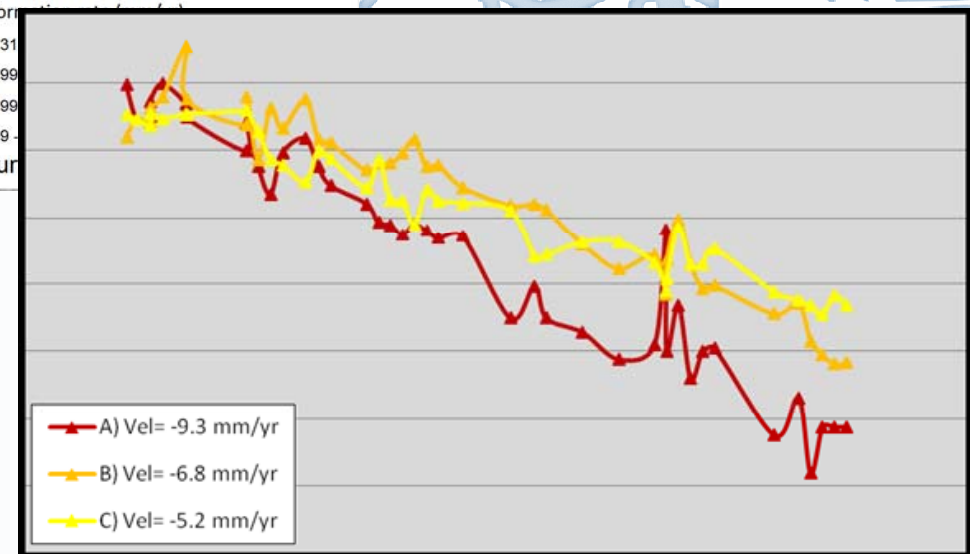
Displacement time series and yearly velocities of PS A, B, and C, located close to the damaged area of Perea village.
