## TRAINING COURSE ON SEISMIC RISK ASSESSMENT IN SPECIFIC AREAS WITH MONUMENTAL STRUCTURES

# Vulnerability models for the seismic risk assessment of monuments

*Sergio Lagomarsino*

Dept. of Civil, Environmental and Architectural Engineering, University of Genoa, Italy

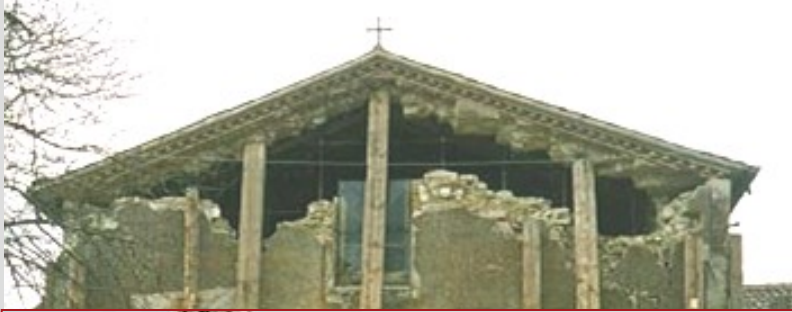
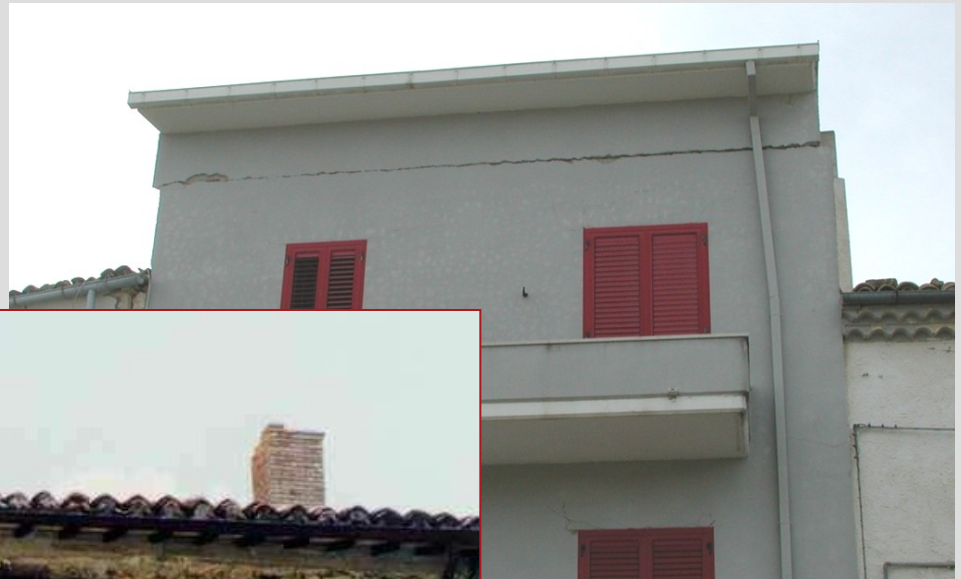
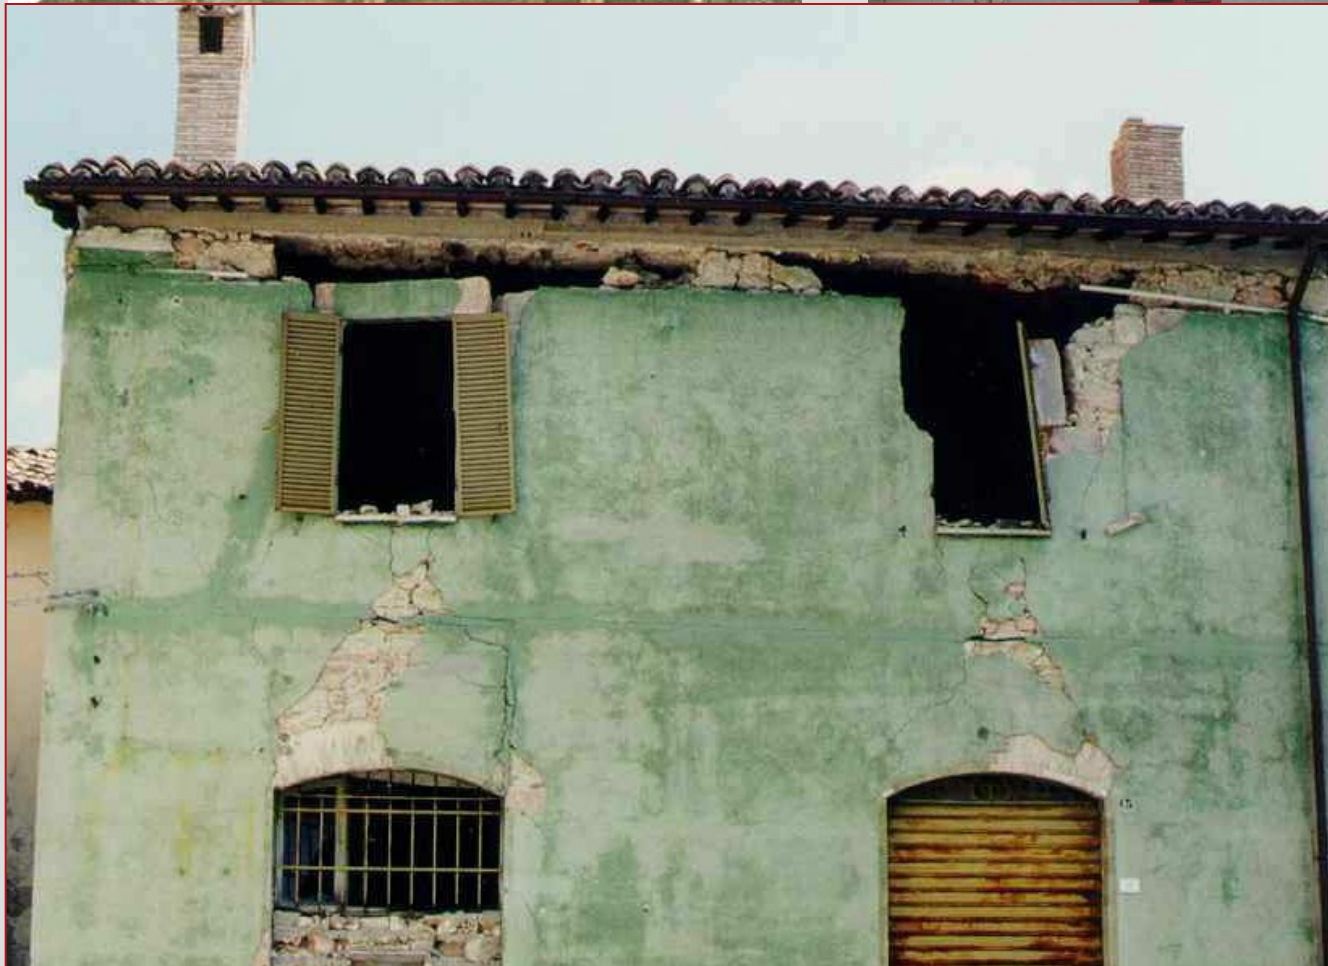
# Insertion of r.c. ring beams and change of timber floors with r.c. slabs

# Increase of masses at roof level and torsional effects due to rigid floors

# Disgregation and sliding between masonry and r.c. ring beams

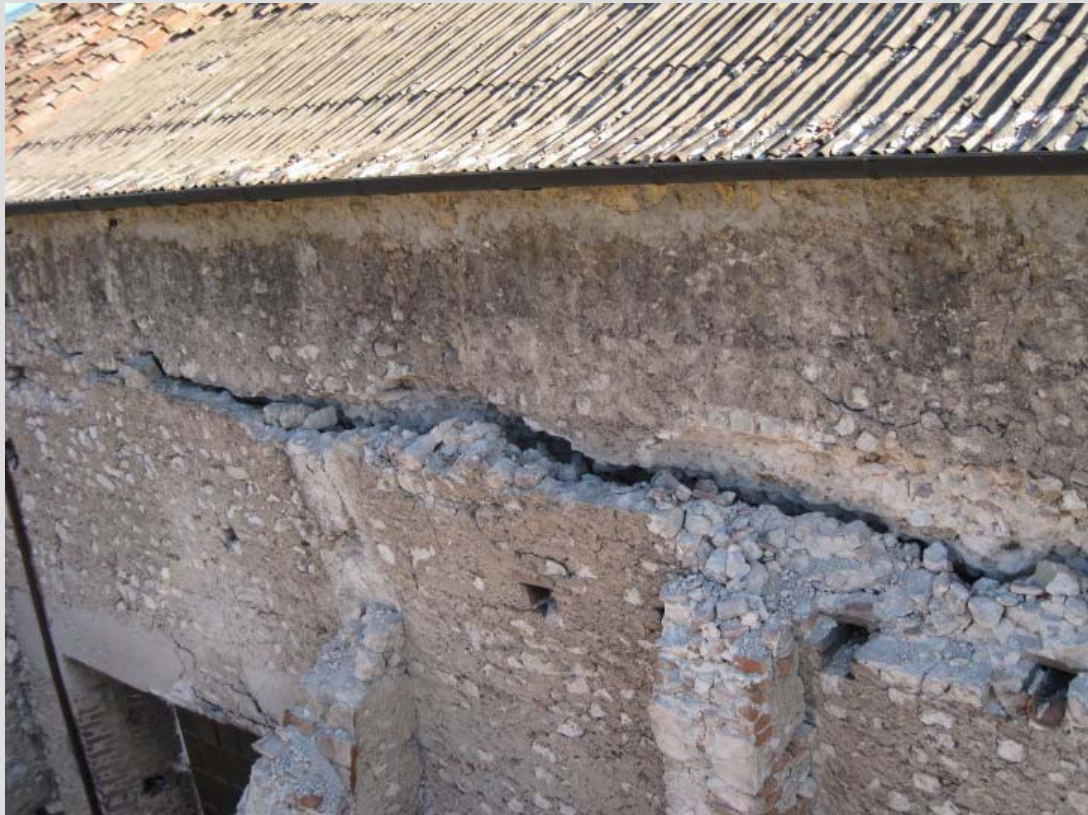
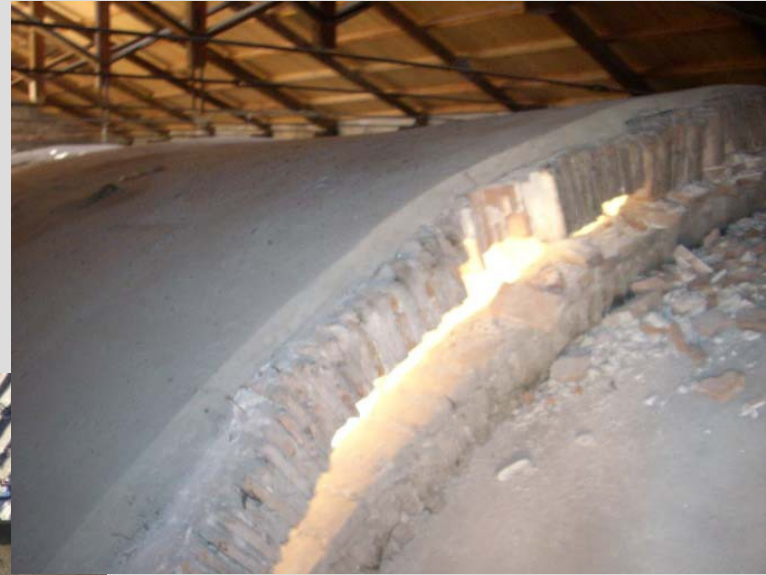
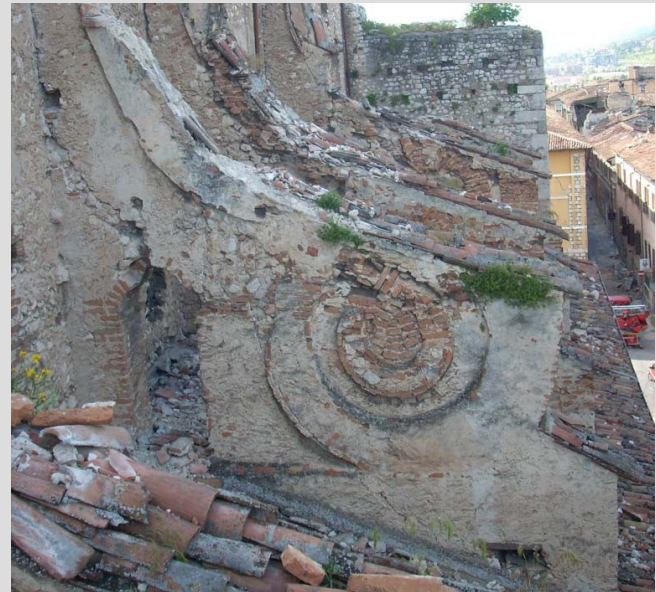
# SANTA MARGHERITA CHURCH - L'AQUILA

Thick R.C. slab over the barrel vault of the nave.  
Out of plane shear failure of the lateral walls.

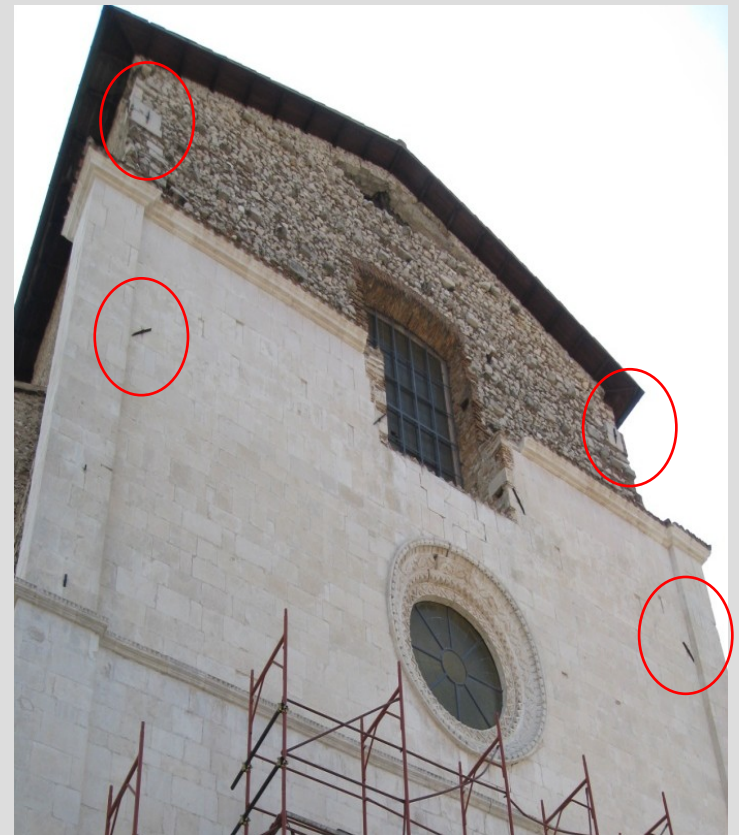
## Overturning of the façade:

**April 15, 2009**

**May 15, 2009**

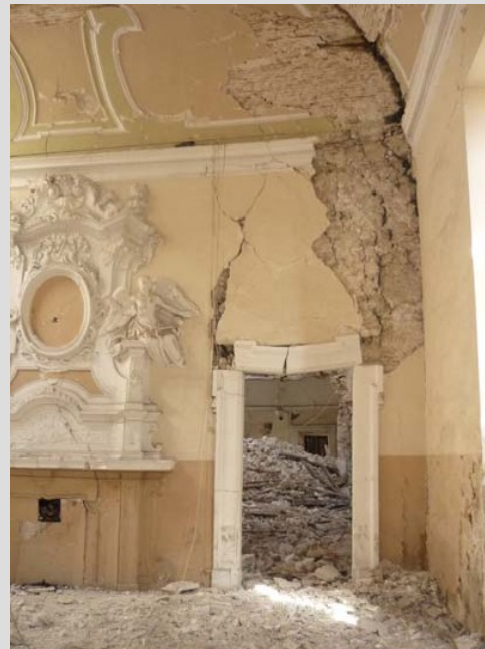
# PALAZZO ARDINGHELLI – damage mechanisms

## Out-of-plane behaviour of the façade

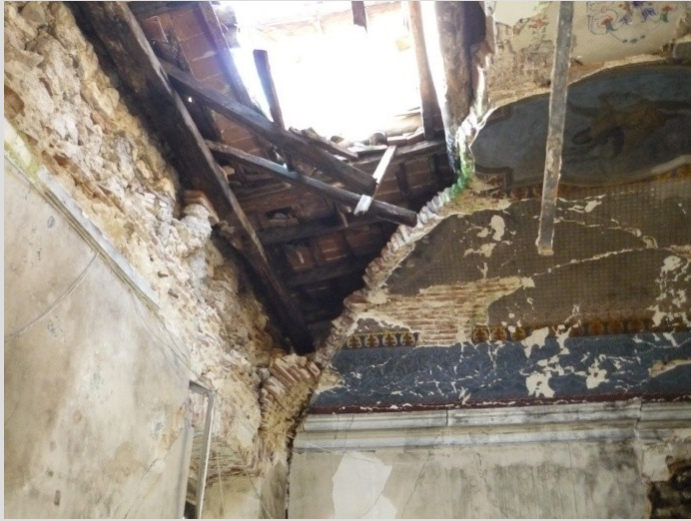
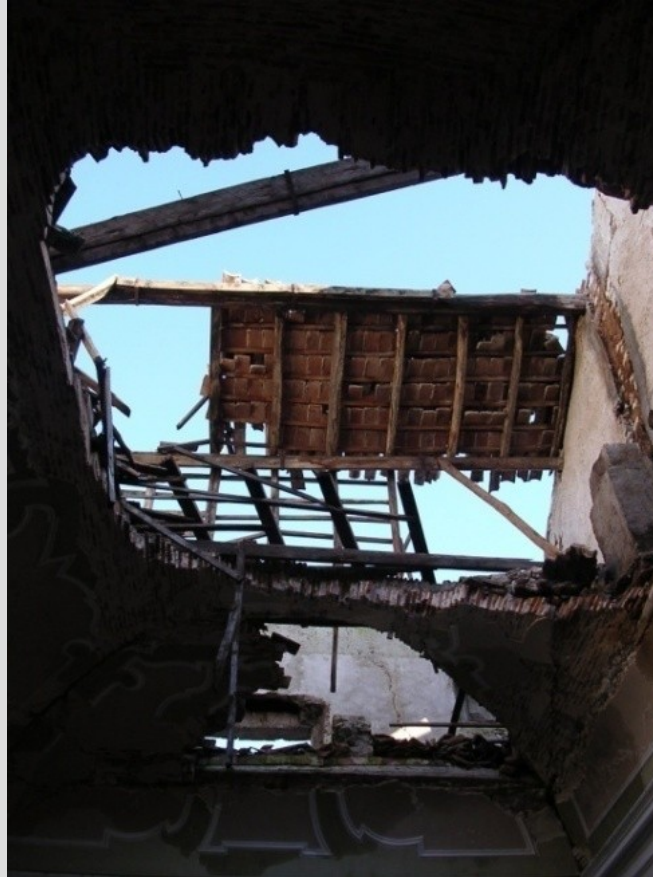
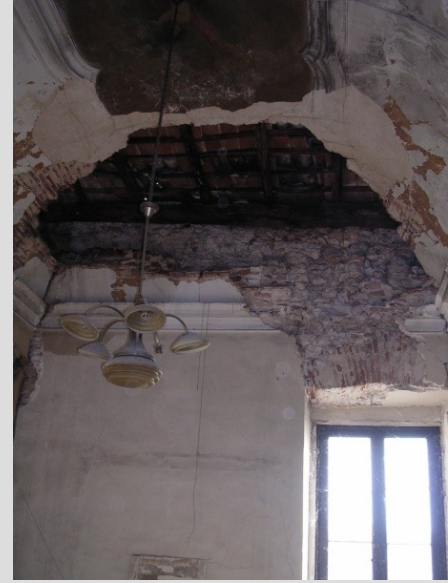
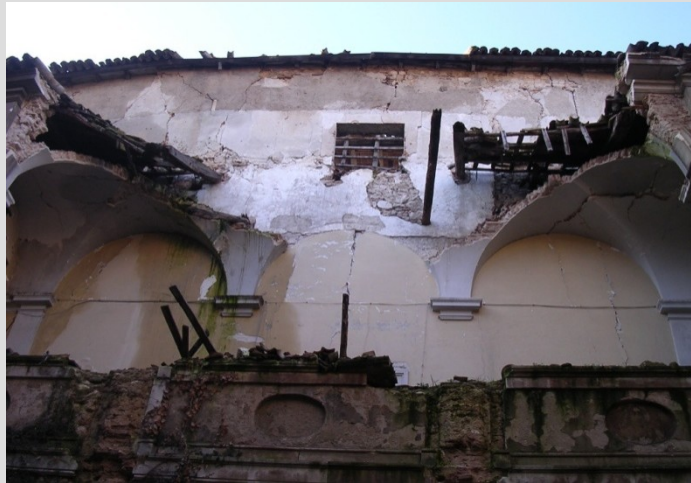
# PALAZZO ARDINGHELLI – damage mechanisms

## Collapse of brick and light vaults
